Historic Preservation Assessment Report

Institute of Texas Culture
801 E Cesar Chavez Blvd.
San Antonio, TX 78205

February 1, 2023

This report includes the existing conditions, goals and recommendations for the University of Texas at San Antonio's Institute of Texas Culture at HemisFair Park.

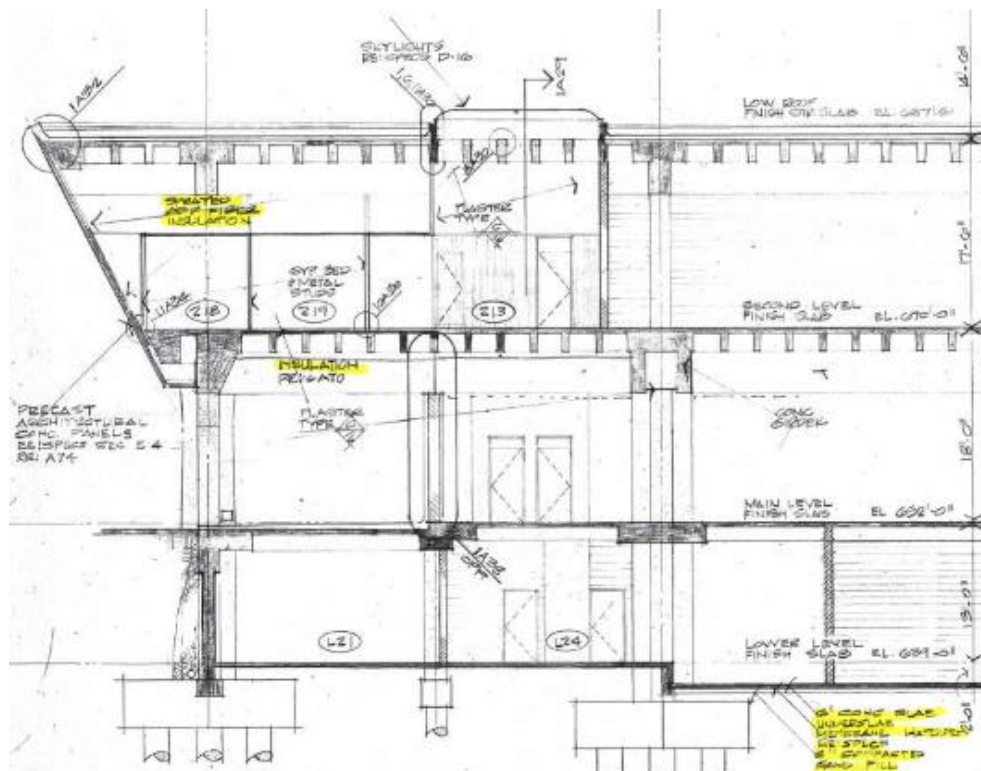
Partial sectional detail, Caudill, Rowlett, Scott Architects – UTSA Special Collections

The AAM accreditation report’s statement that “The ITC started as a short-term exhibition center, one with no mandate to collect” is not accurate, according to the original vision of R. Henderson Shuffler. Whether or not the building was built to any accreditation standards that may have existed in 1968 is unknown. The AAM report’s statement that “no part of the building was built with a vapor barrier” is improbable. Building codes in 1968 addressed building envelope issues such as insulation and moisture control. Further, the original drawings provided by UTSA Special Collections show that the design intent was for the lower-level slab to be installed over membrane waterproofing on 6” of compacted sand fill. The drawings do not include section details of the wall assemblies but building sections do call for insulation. Insulation is not a vapor barrier, but it basic vapor barriers were in use at this time.

Further investigation is needed to understand the extent of insulation and moisture protection in the existing building assemblies. There are options for installing vapor protection into existing assemblies that would not compromise the historic character of the building.

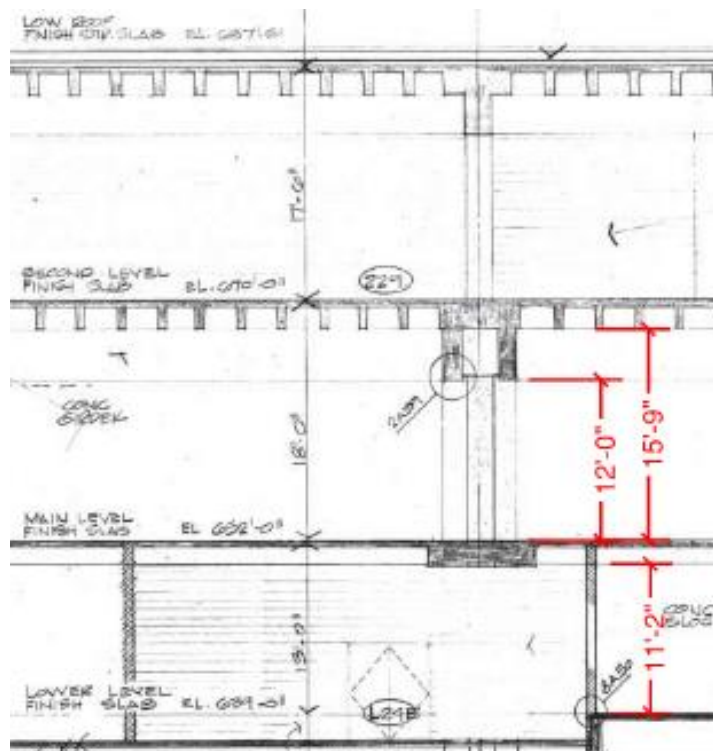
Partial sectional detail, Caudill, Rowlett, Scott Architects – UTSA Special Collections

2. The AAM report notes ceiling heights of 10' to 12' on the main floor. However, the provided original drawings show bottom of structure on the main level to be approximately 15'-9". (Clear height under the beams at the column lines is 12'-0".) Lower-level clear dimensions to bottom of structure are approximately 11'-2". These dimensions should be verified and the AAM report updated, as appropriate. Since the original exhibition areas did not have ceilings (the structural system was exposed) the institute should be able to utilize the full height of these areas. If greater ceiling height is required in some areas of the lower level for collections storage, etc. ceilings in back-of-house areas can be raised or removed without negatively impacting the historic nature of the building.

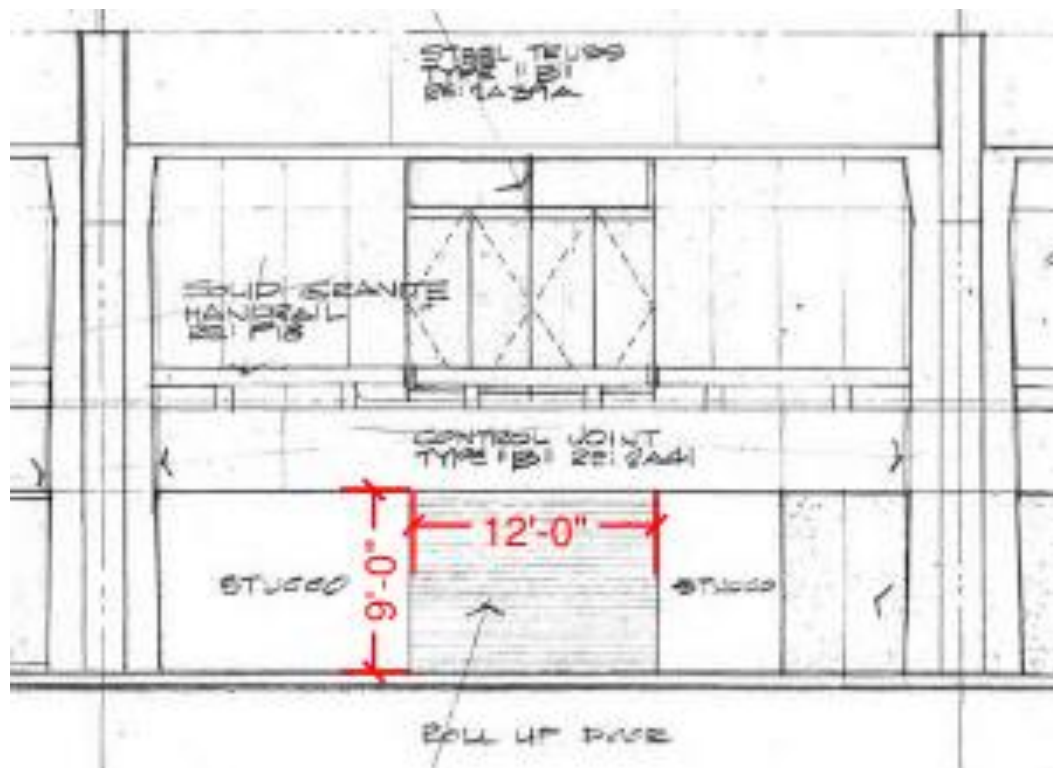
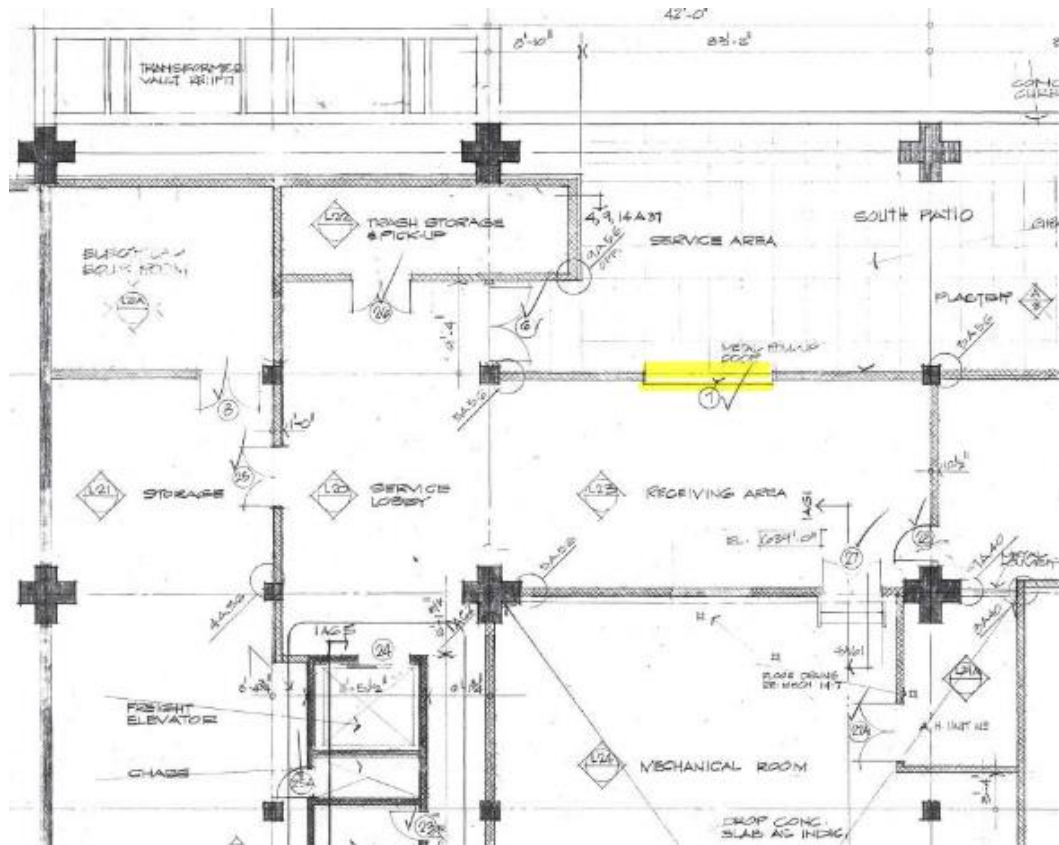
The existing loading dock does not meet AAM accreditation requirements. The original loading dock has been modified and now serves as an office. Drawings indicate the original rolling door was 9’-0” tall and 12’-0” wide. Modifications to meet loading dock height dimensions may be difficult, but the loading area can be improved by reverting to the original design.

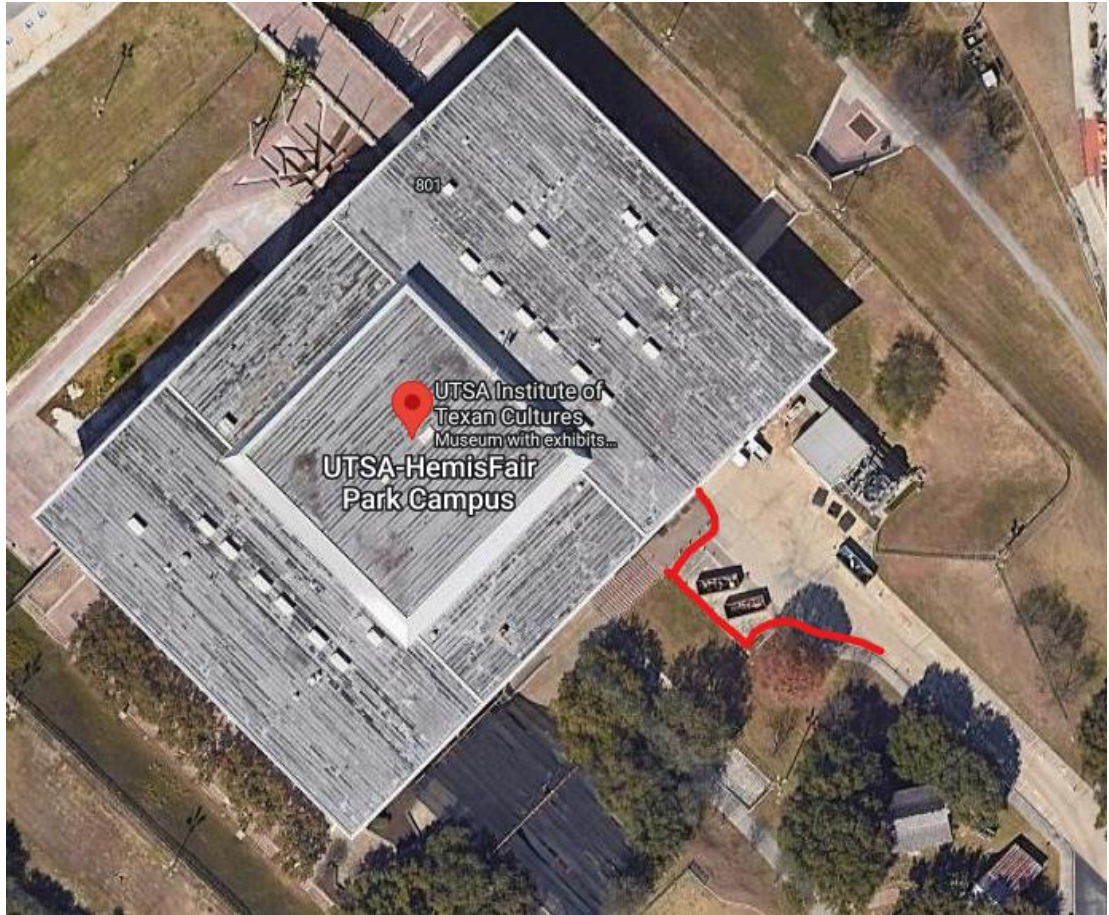
Aerial view of Texas Pavilion Site – Google Earth

The AAM accreditation reports notes a lack of turn-around space for large trucks. However, the site does include a parking area (currently occupied by two larger dumpsters) that could be used as a hammer-head turn-around in the service drive. The dimensions of this parking need to be verified, and a turn-radius study performed by a traffic engineer in order to determine the size of trucks that can be accommodated without modifying the area. If additional space is needed, the berm at the head of the parking area could be removed by installing a retaining wall, therefore increasing the depth of the turning bay.

If renovations interior to the building cannot meet AAM accreditation standards, it may be possible to improve the loading functions of the facility with an addition to the exterior of the existing loading dock. These modifications can be accommodated without negatively impacting the historic nature of the building. Additions to historic buildings, are not however, considered “qualified rehabilitation expenditures” and that portion of the rehabilitation cost would not count toward state or federal tax credits.

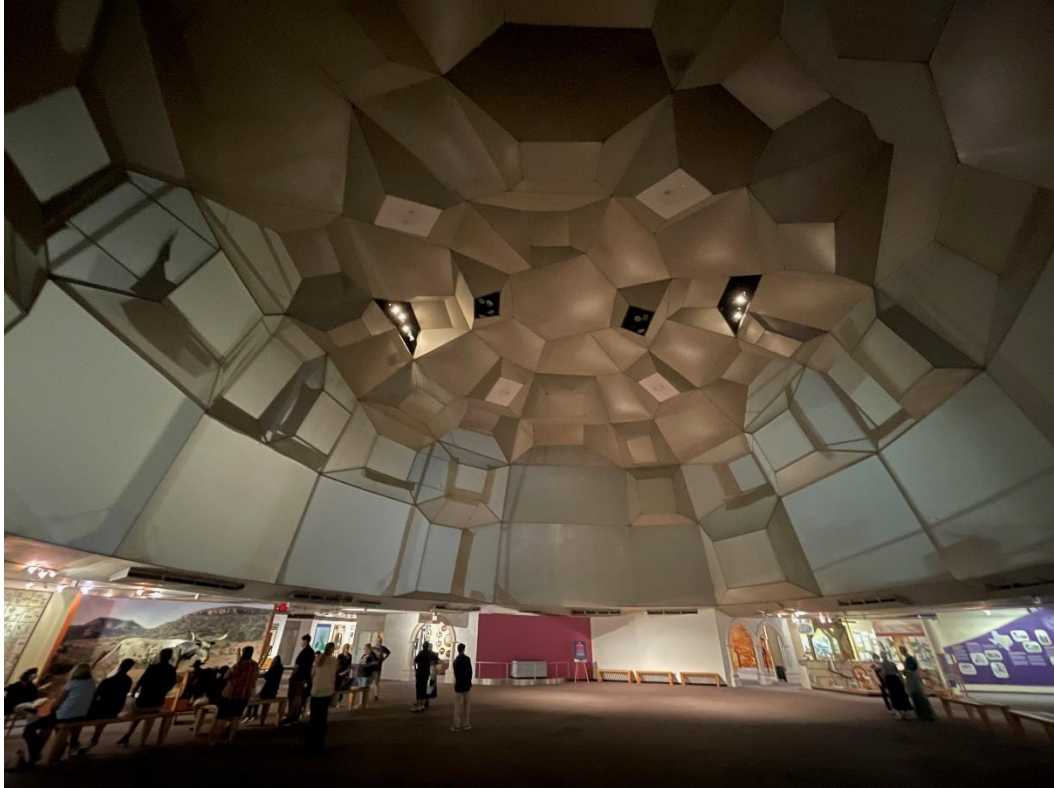
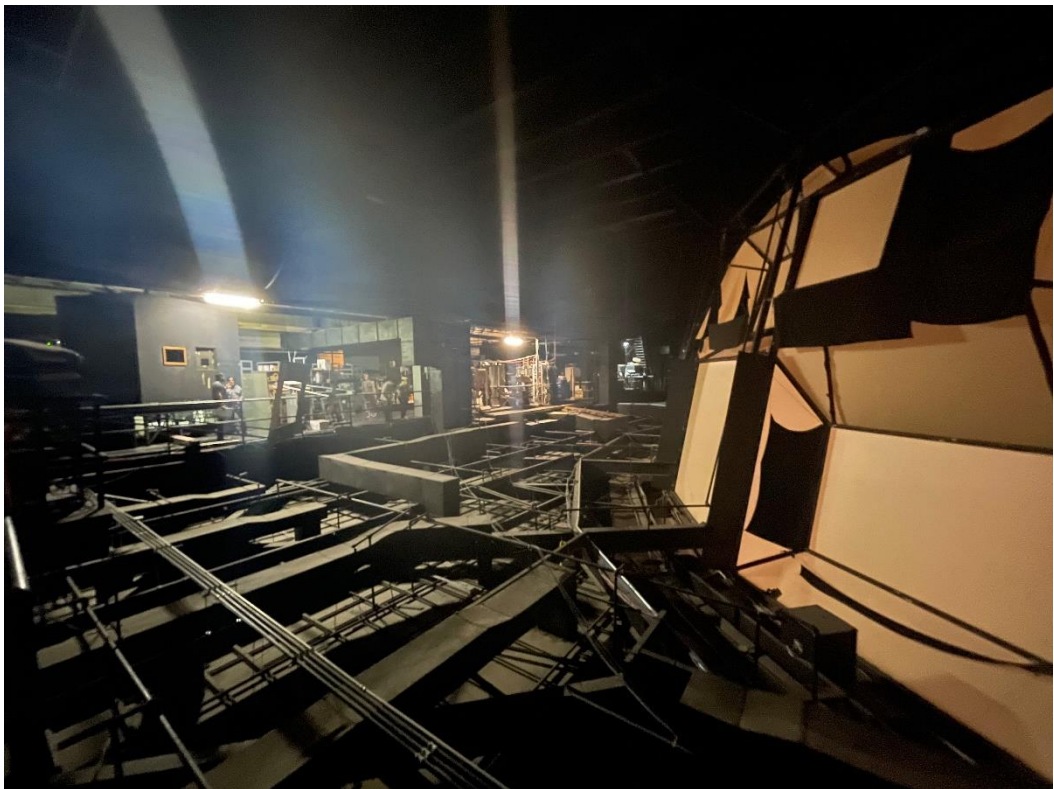
2. The mechanical system returns through a series of large wood-slat grills on all levels. On the upper, third level, it was observed that the mechanical return appeared to draw through the Globe Theater, into the upper-level returns. Further, there does not appear to be any fire or smoke separation between the second and third levels. With the open stair connecting the lower level to the middle, second level, and then the unprotected opening of the Globe Theater through to the third level, the building effectively has an atrium condition connecting three levels and does not meet current building codes for this condition.

2. "The Main Gallery floor's central, very large two-story "Dome Theatre" space is a fire chimney..." It is accurate to state the Dome Theater does not meet current fire/smoke separation requirements and may in fact create a "chimney" effect if a fire were to breakout in the gallery area. This can be corrected by constructing properly rated fire/smoke partitions around the dome opening on the third level. The fabric screen assemblies can be treated with fire-retardants or replaced with compliant materials that match the historic appearance of the existing screens. Further investigation of the building's mechanical system is needed to determine the return air pathway from Level 2 to Level 3. Additional comments regarding the safety of the existing projection equipment and the upper-level staff catwalks, etc. can be corrected. These items are back-of-house and can be replaced and/or modified without impacting the historic character of the theater. Seating can be provided in the lower level to better accommodate guests, provided it is not a permanent installation. The Dome Theater is a significant historic feature of the building and participation in the state or federal tax credit programs will require it to be retained.
