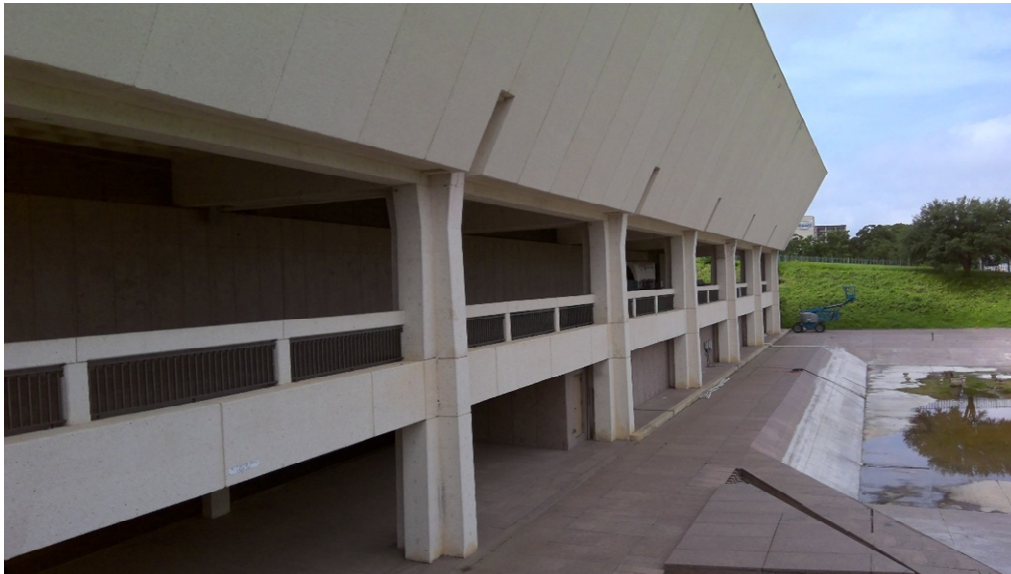
**Photo 1:** Overall view of the West exterior side of the building looking towards the Southwest at the main entry into the exhibit area.

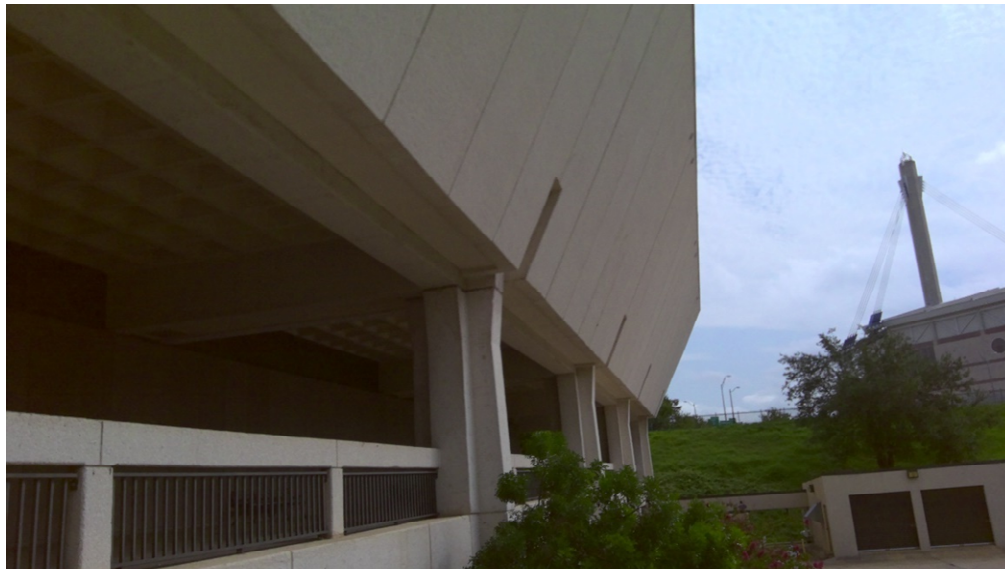
**Photo 2:** Overall view of the East exterior side of the building looking towards the Northeast at the entry into the lower level.

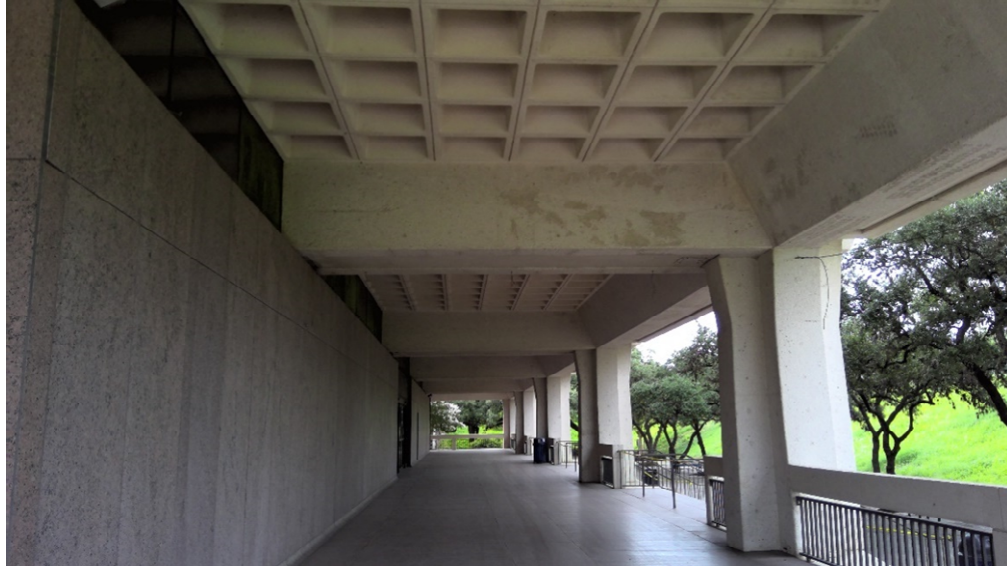
**Photo 3:** Overall view of the South exterior corridor of the building looking towards the Southeast.

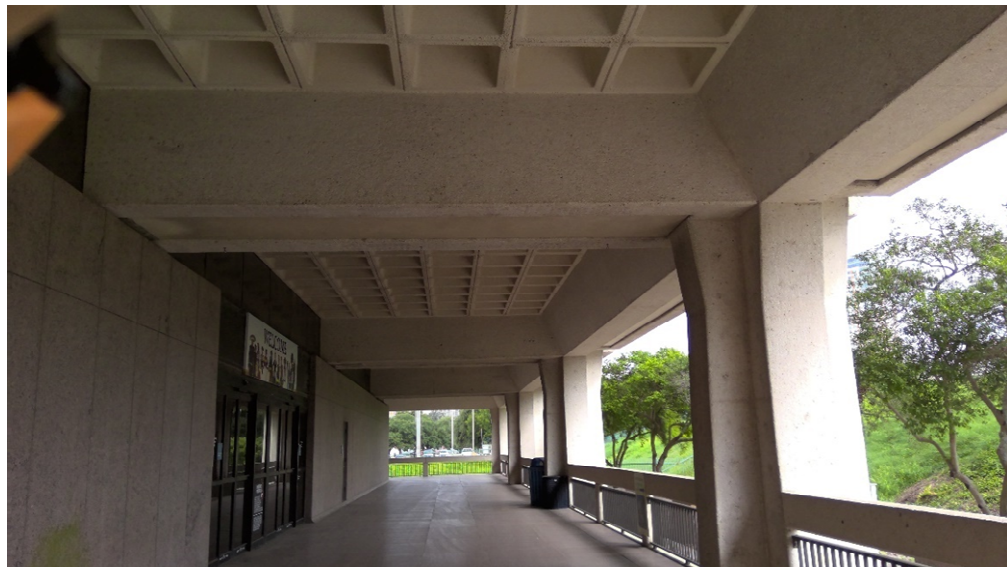
**Photo 4:** Overall view of the North exterior corridor of the building looking towards the Northwest.

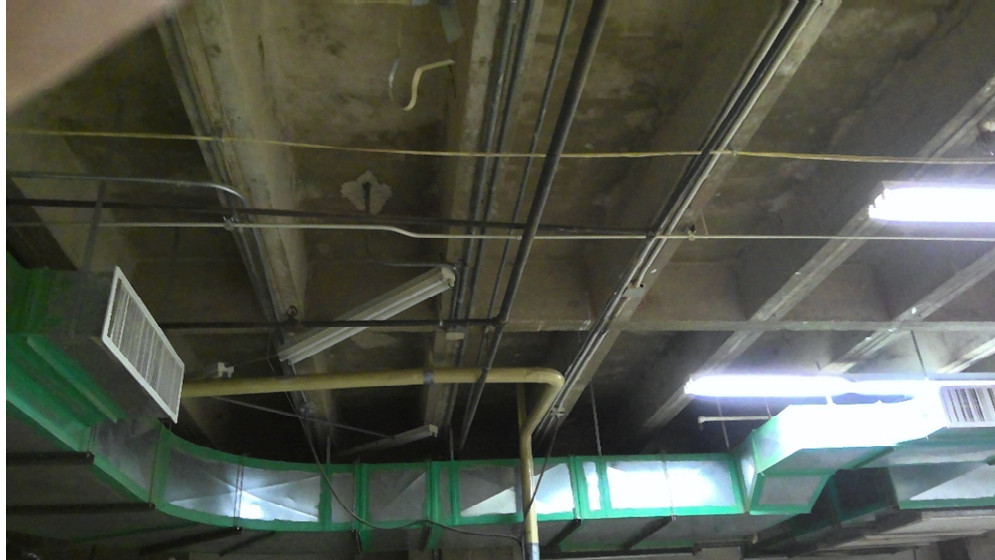
**Photo 5:** A concrete one-way joist system was evident for the support of the exhibit Second-Floor level.

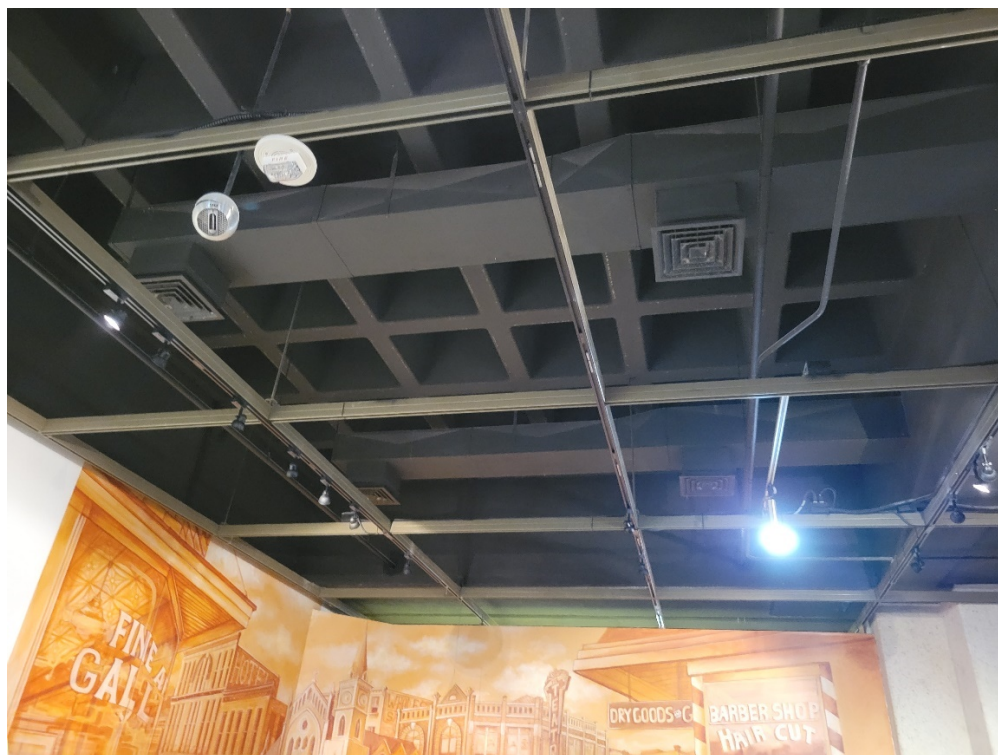
**Photo 6:** The deeper concrete waffle slab was evident for the Third-Floor framing from below throughout the exhibit Second-Floor level through the open cloud ceiling.

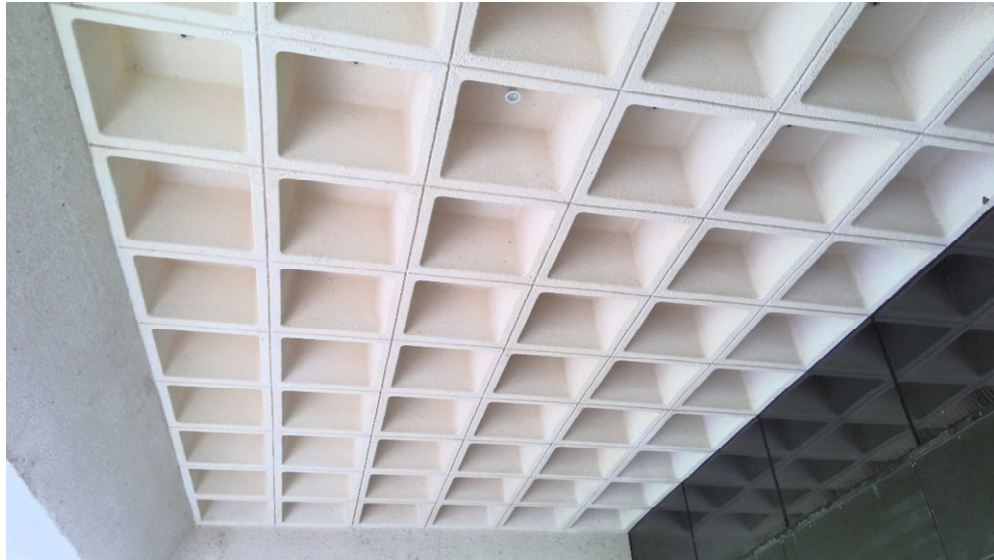
**Photo 7:** The shallower concrete waffle slab was also evident for the Third-Floor level at the exposed exterior corridor all around the perimeter of the entire building.

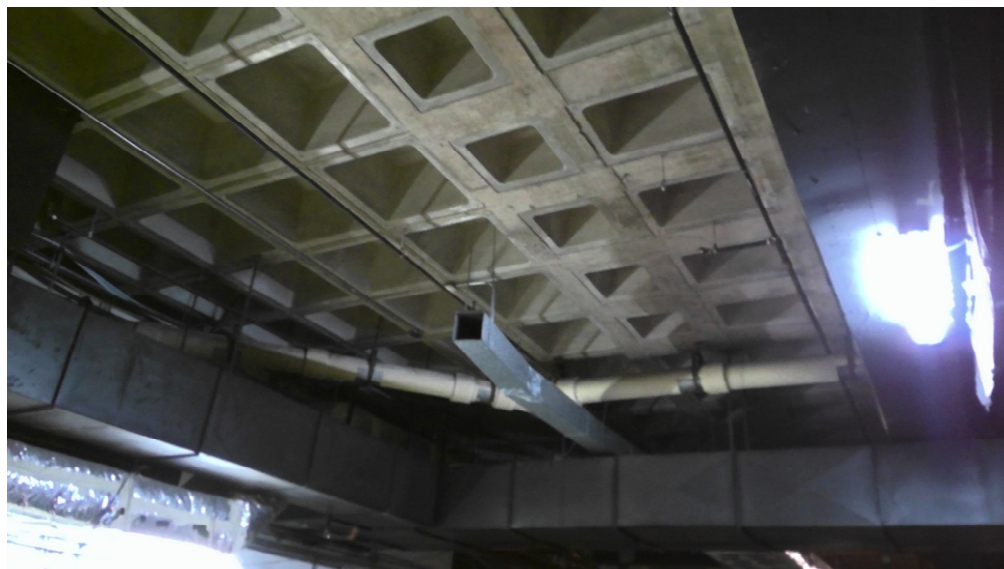
**Photo 8:** A concrete waffle slab was evident for the low concrete roof level along with the widened joists along the perimeter of the dome opening for support of the steel High Roof above.

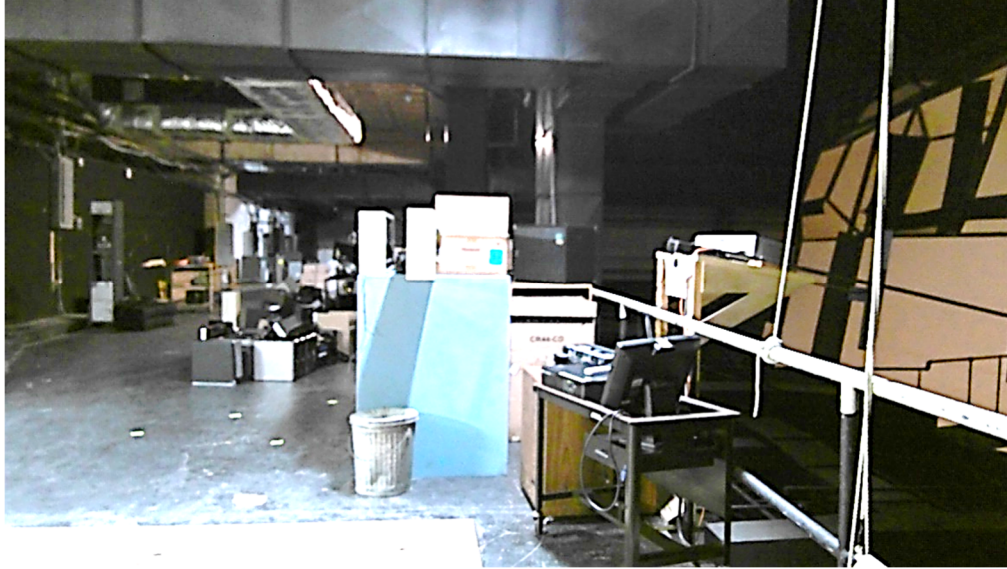
**Photo 9:** The steel structure was evident for support of the dome ceiling suspended from the steel High Roof level with horizontal radial steel framing at the Second-Floor level ceiling supported to the side of the concrete perimeter beams for the dome opening on the concrete third floor framing.

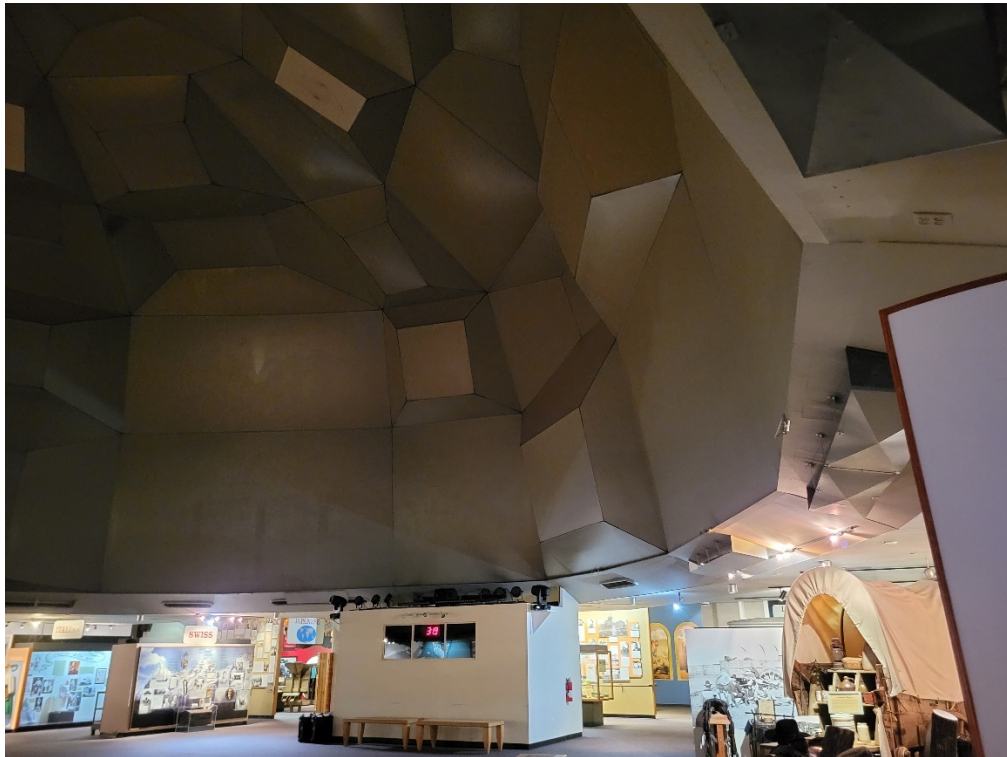
**Photo 10:** The dome ceiling was evident looking up from the exhibit Second-Floor level extending through the opening on the Third-Floor level, the opening on the concrete Low Roof level, and on up to the underside of the steel High Roof level.

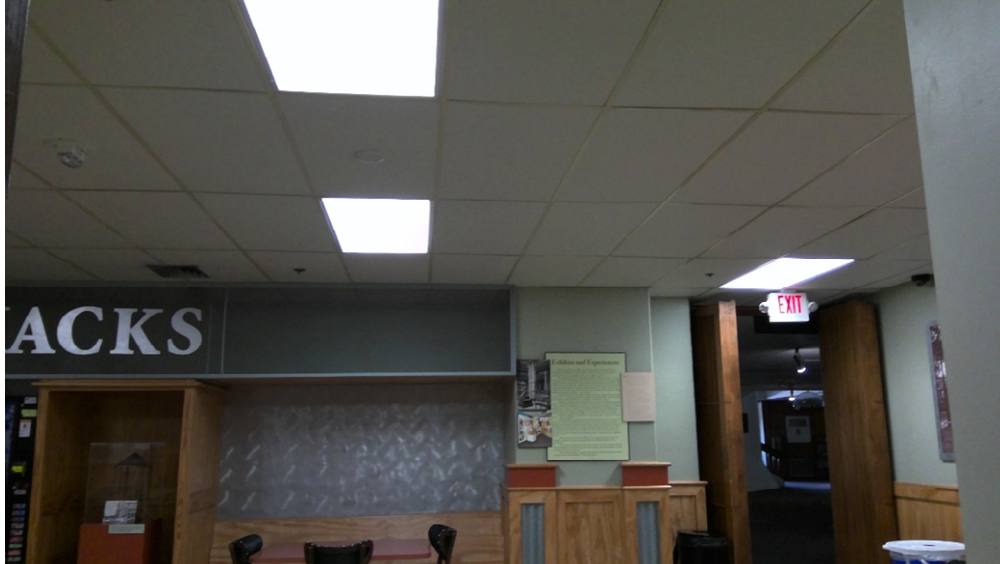
**Photo 11:** For the first floor supported by the Second-Floor framing, lay-in ceiling was observed for typical office spaces, lounges, conferences rooms and miscellaneous rooms for workspaces and light storage rooms.

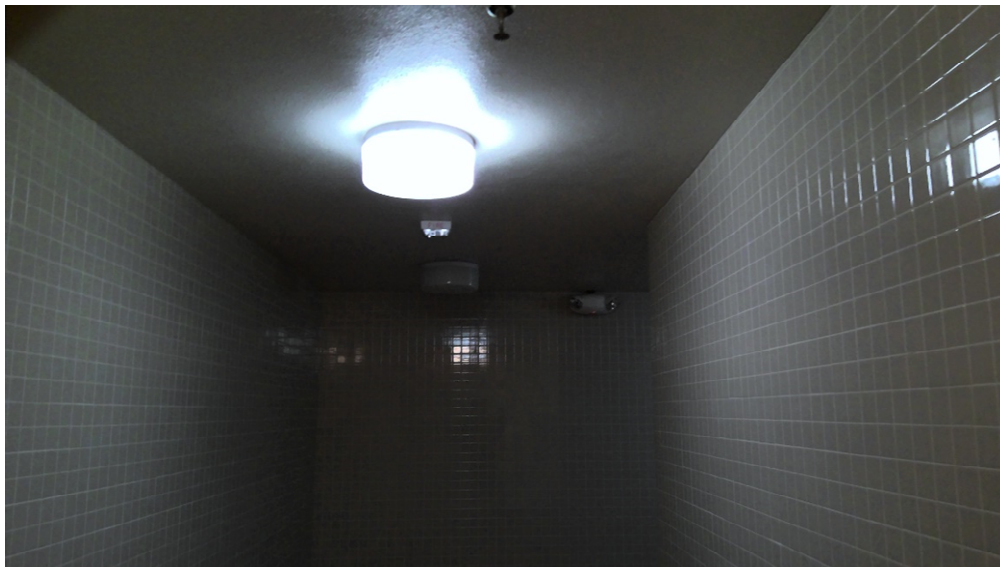
**Photo 12:** For the First-Floor supported by the Second-Floor framing, gyp-board ceiling was observed for all restrooms, open areas near the entries into the First-Floor level, small storage rooms, and miscellaneous rooms that were too small to install a lay-in ceiling.

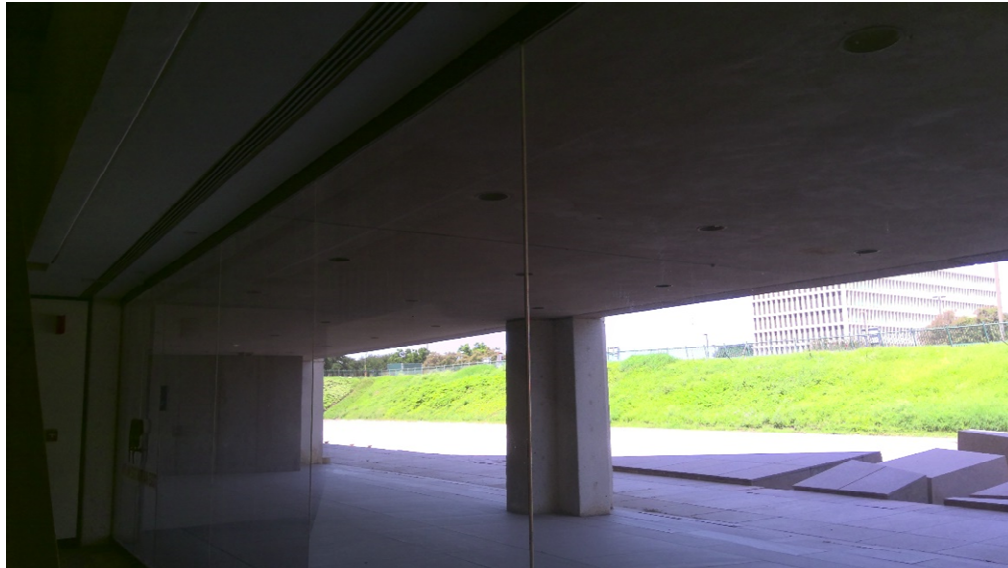
**Photo 13:** For the First-Floor supported by the Second-Floor framing, plaster was observed for the exterior soffits at the recessed entries on both the East and West side of the building.

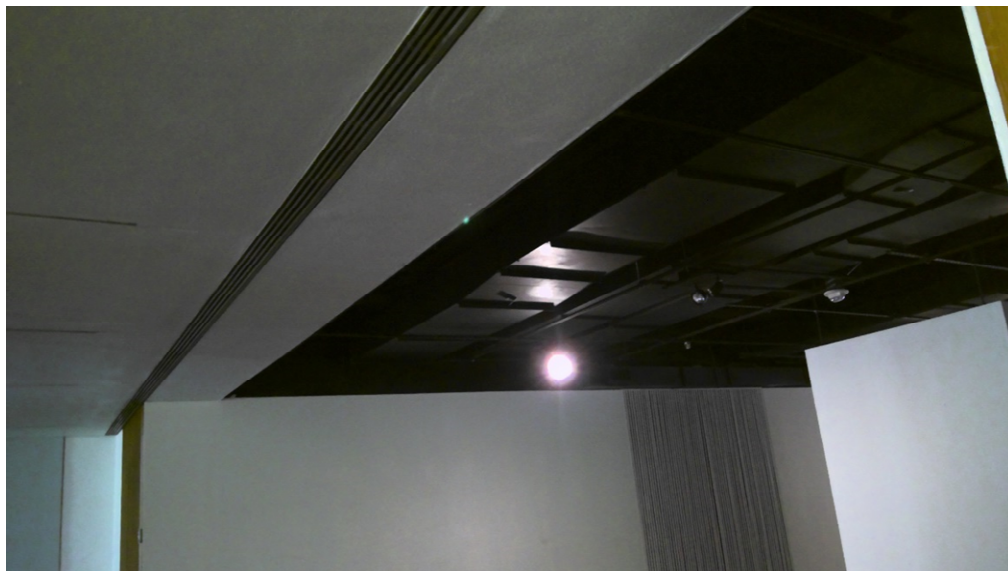
**Photo 14:** For the First-Floor supported by the Second-Floor framing, a cloud ceiling was observed with a suspended channel system without the lay-in fiberboard at the main corridor.

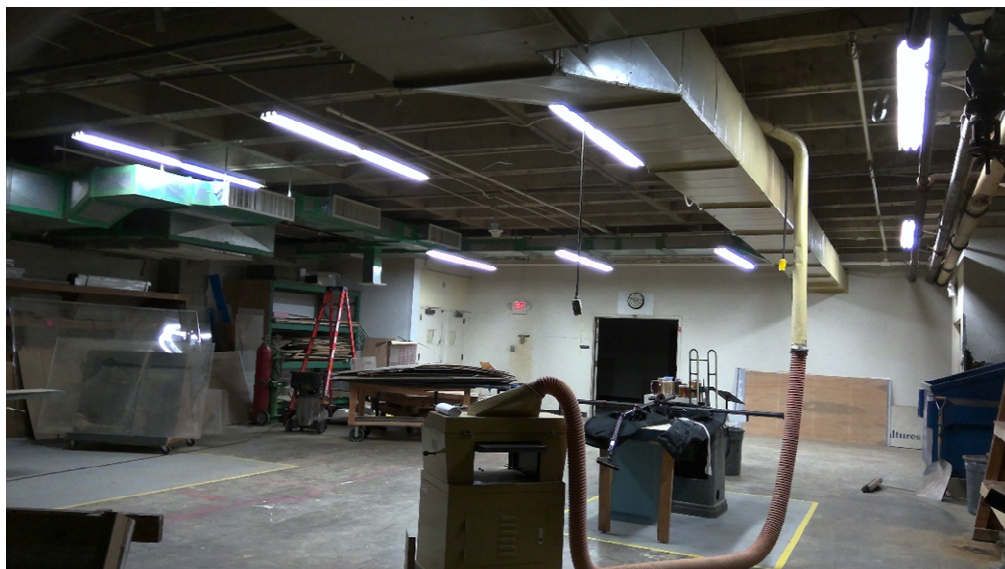
**Photo 15:** For the First-Floor, there were exposed areas of the Second-Floor framing observed for large workspaces, mechanical rooms, corridors leading into the mechanical rooms, and large storage spaces.

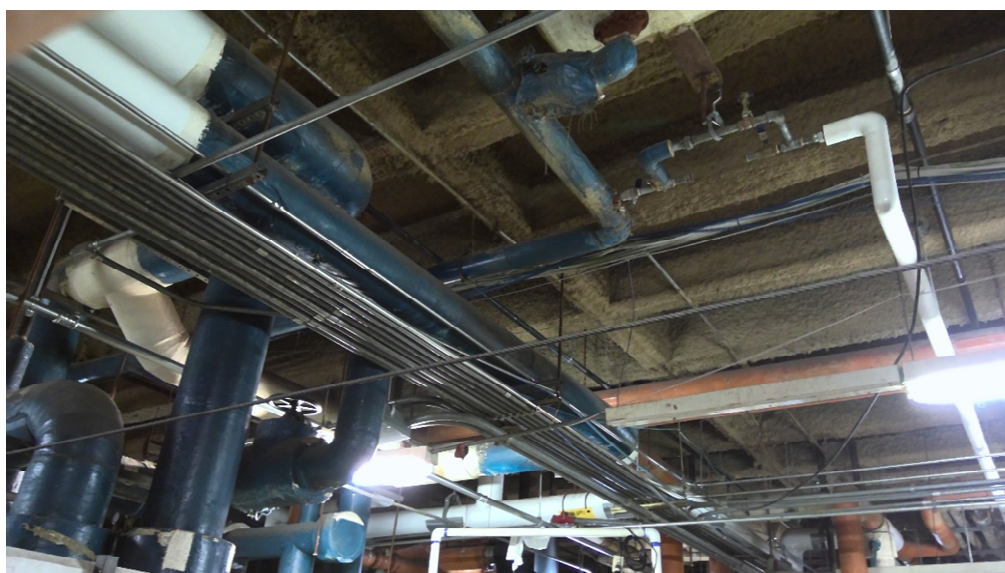
**Photo 16:** For the First-Floor, there were exposed areas of the Second-Floor framing observed with limited spray-on insulation in random mechanical rooms.

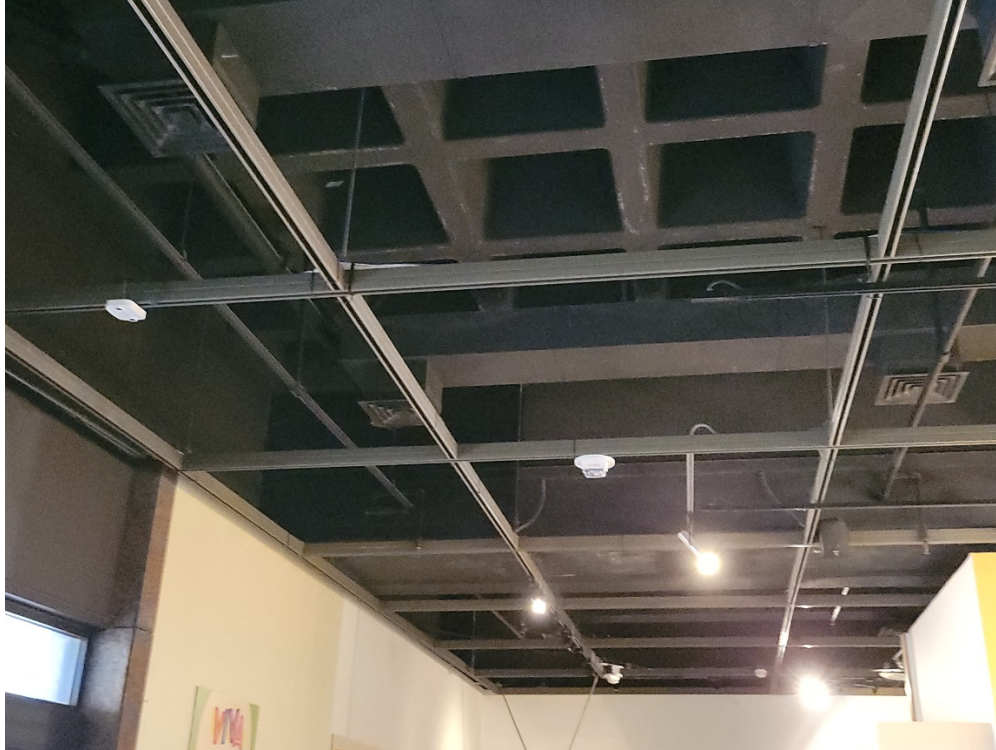
**Photo 17:** For the exhibit Second-Floor supported by the Third-Floor framing, a cloud ceiling was observed with a suspended channel system without the lay-in fiberboard throughout the entire floor within the interior of the building.

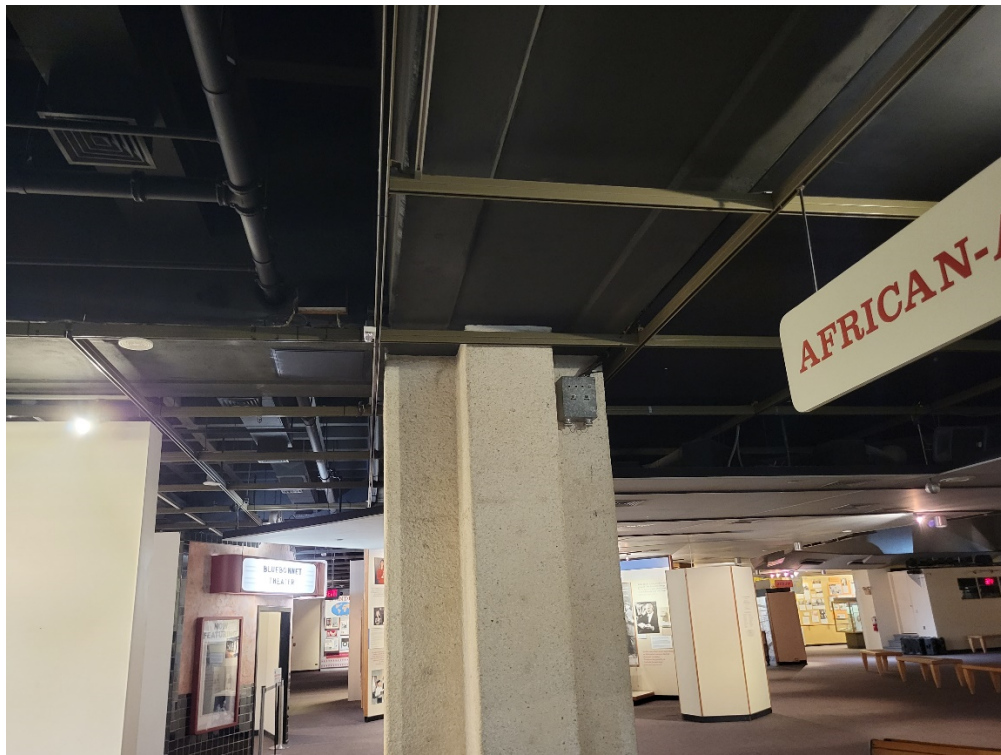
**Photo 18:** For the exhibit Second-Floor supported by the Third-Floor framing, a gyp-board ceiling was observed with a suspended channel system below without the lay-in fiberboard within the opening for the dome creating a square band in the dome opening.

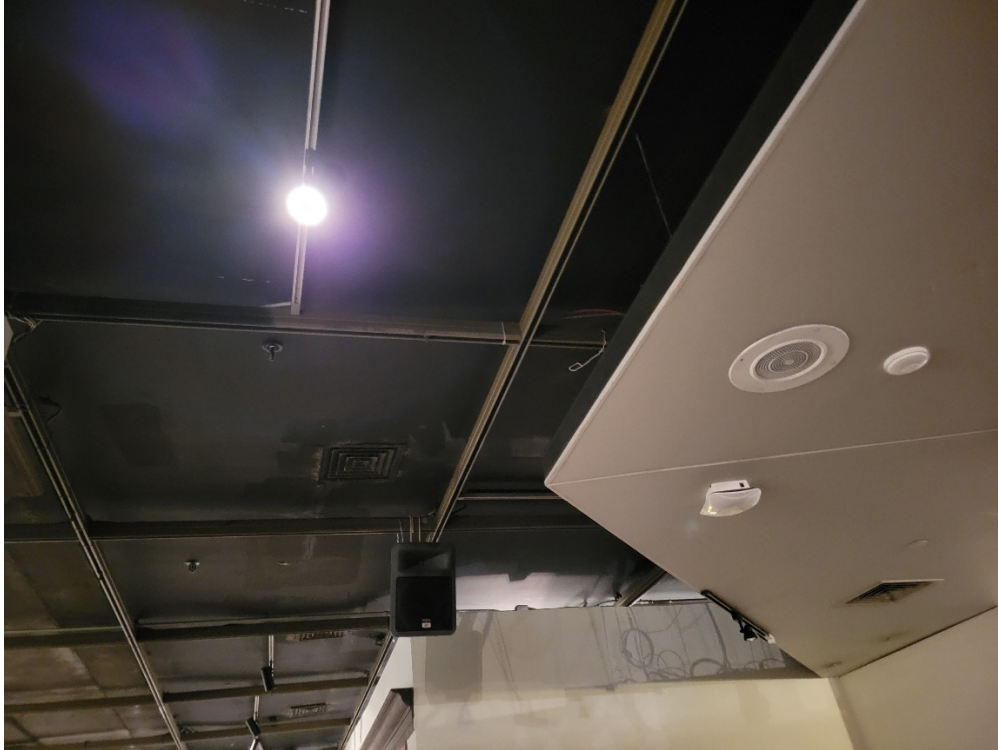
**Photo 19:** For the exhibit Second-Floor supported by the Third-Floor framing, a double gyp-board ceiling was observed with a second layer of gyp-board supported by the upper layer of gyp-board within an irregular transition layout around the dome opening.

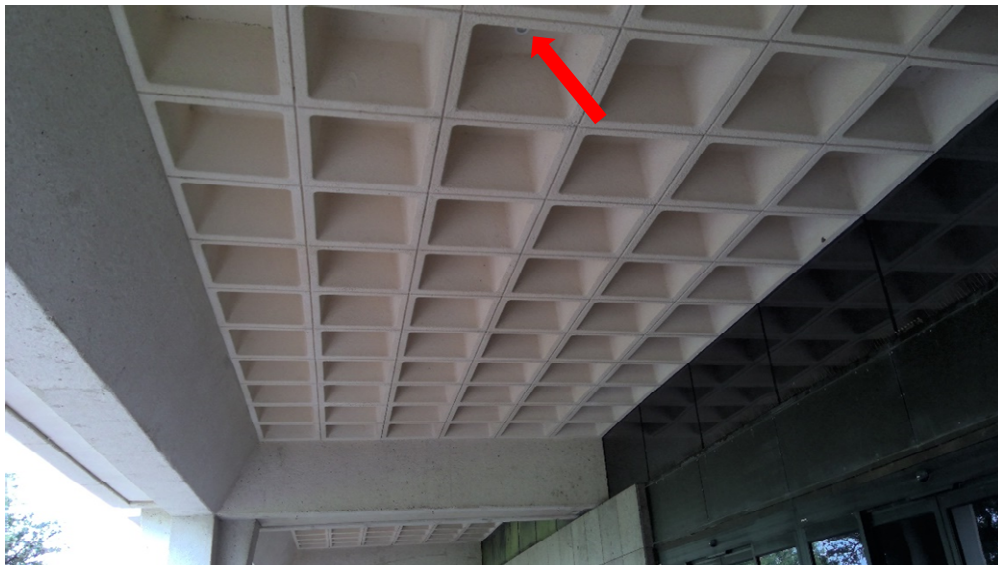
**Photo 20:** For the exterior corridor at the exhibit Second-Floor supported by the Third-Floor framing, minimal lighting but no other collateral load was observed for the exposed exterior shallow waffle slab concrete framing.

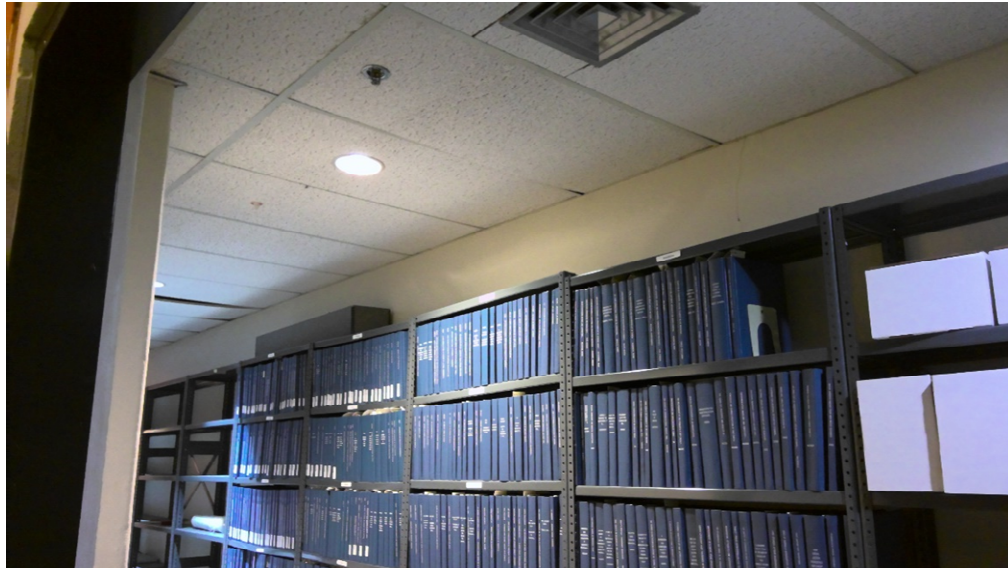
**Photo 21:** For the Third-Floor supported by the concrete Low Roof framing, lay-in ceiling was observed for typical office spaces, lounges, conferences rooms and miscellaneous rooms for workspaces and light storage rooms.

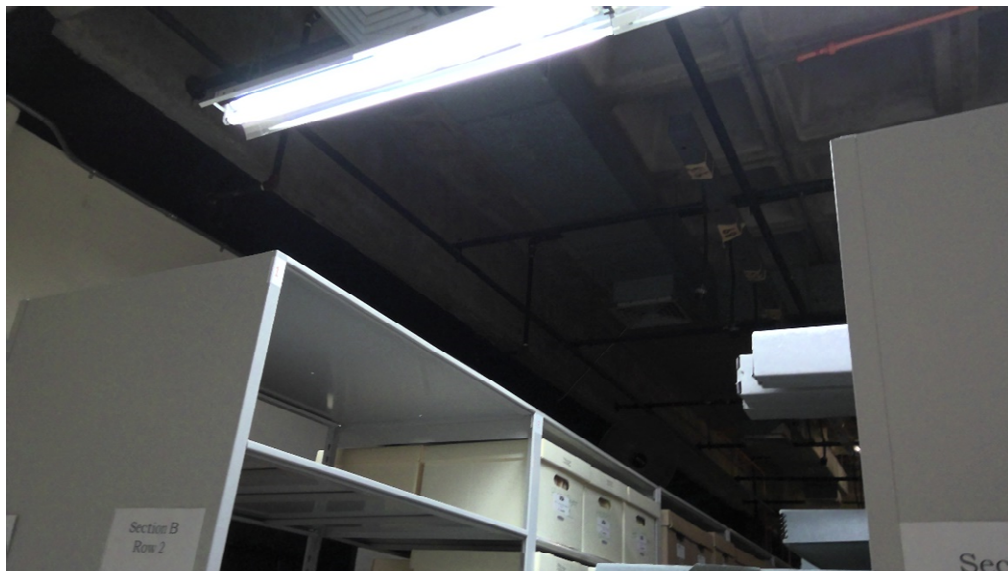
**Photo 22:** For the Third-Floor, there were exposed areas of the concrete Low Roof framing observed for the large storage spaces and the mechanical rooms.

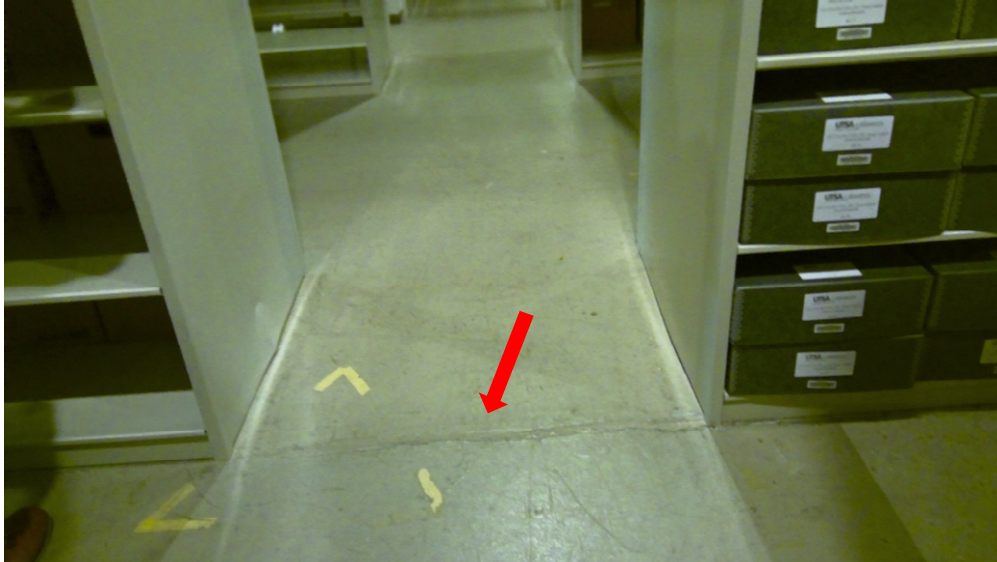
**Photo 23:** A 3" floor depression was designated on the existing structural drawings which marks the transition of the shallow and deeper joists along the entire perimeter of the building which appeared to have a 3" concrete topping over the exterior corridor below.

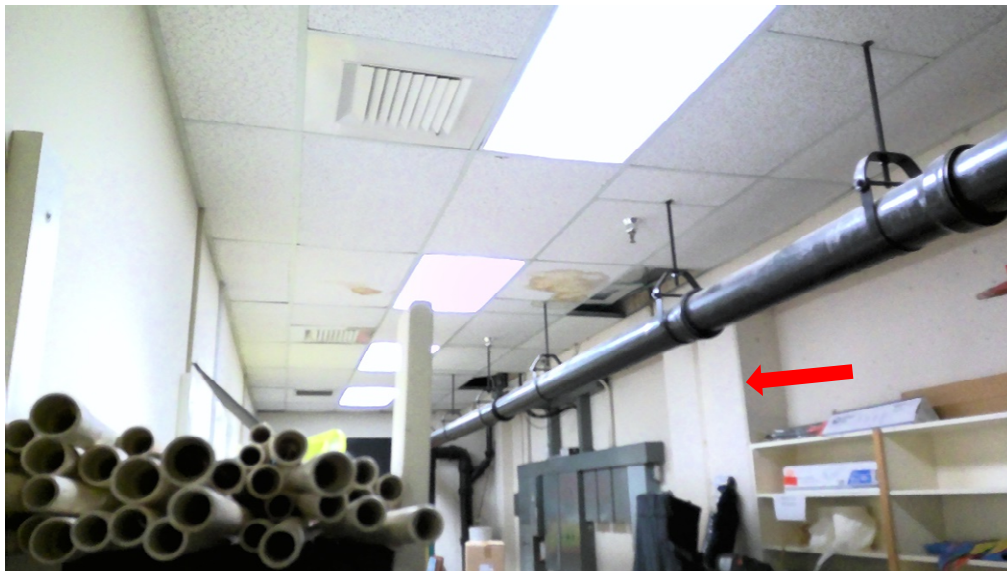
**Photo 24:** For the First-Floor, the double concrete square columns were observed at the single expansion joint from the First-Floor level up to the exhibit Second-Floor level.

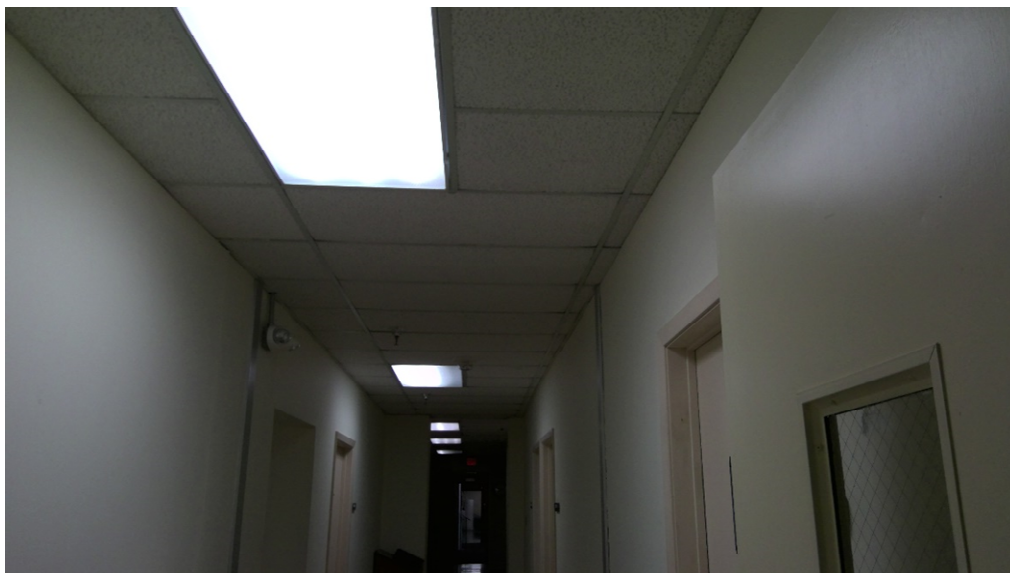
**Photo 25:** For the First-Floor, the expansion joint was carried through the gyp-board walls and no apparent distress was observed at any of these locations.

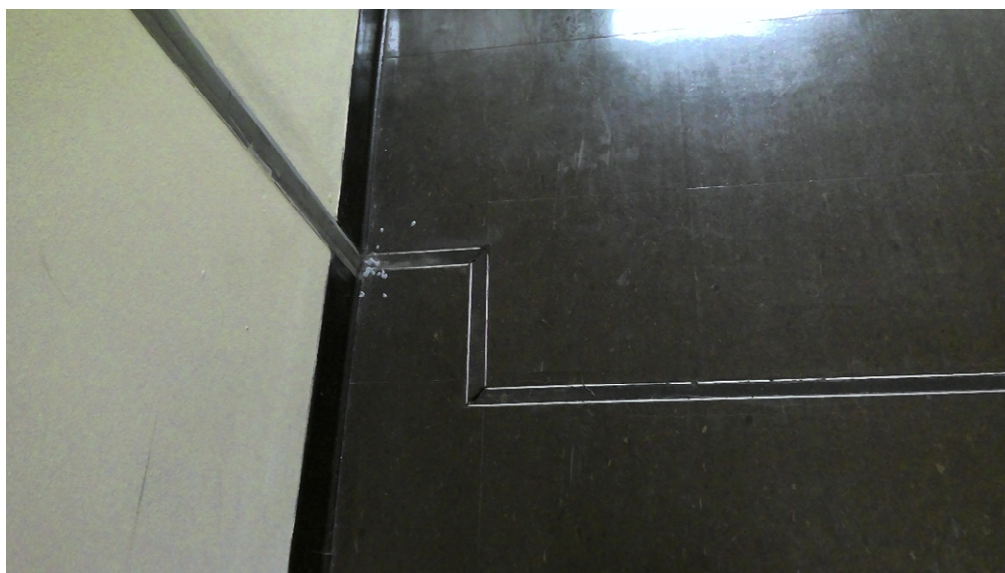
**Photo 26:** For the Second-Floor, the expansion joint was observed from above on the Third-Floor which extends from the Second-Floor and the upper gyp-board walls which follows the details provided within the existing structural drawings.

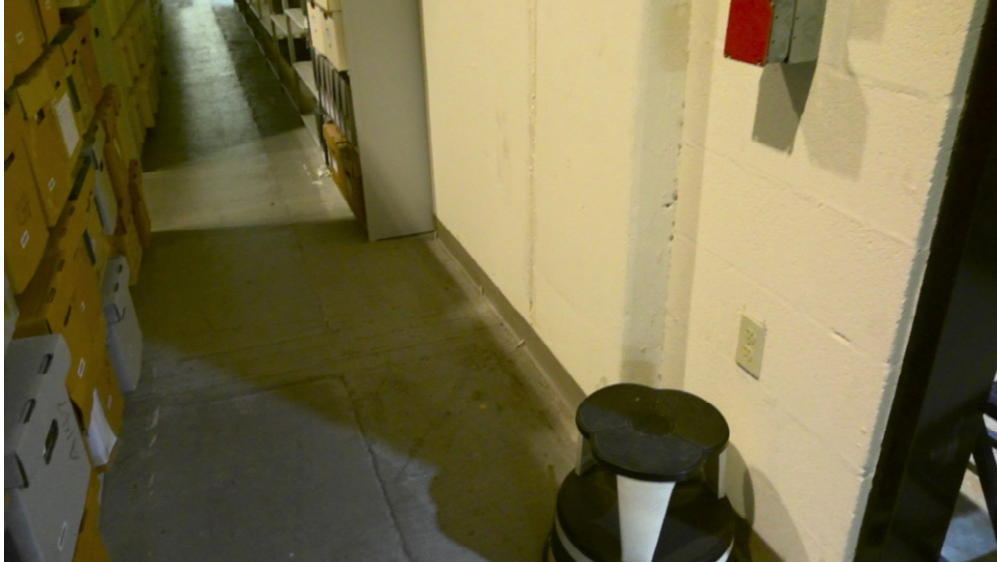
**Photo 27:** For the Third-Floor, the double concrete columns were observed at the expansion joint from the Third-Floor level up to the concrete Low Roof framing creating a small square column and a longer rectangular column which follows the details provided within the existing structural drawings.

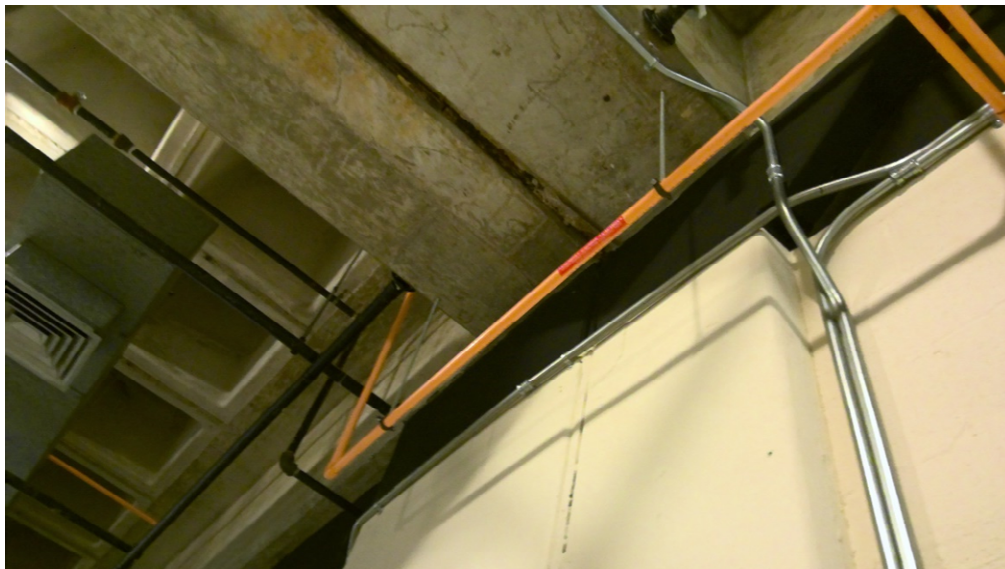
**Photo 28:** For the concrete Low Roof framing, the double concrete beams were observed, one on each side of the expansion joint, which follow the details provided within the existing structural drawings.

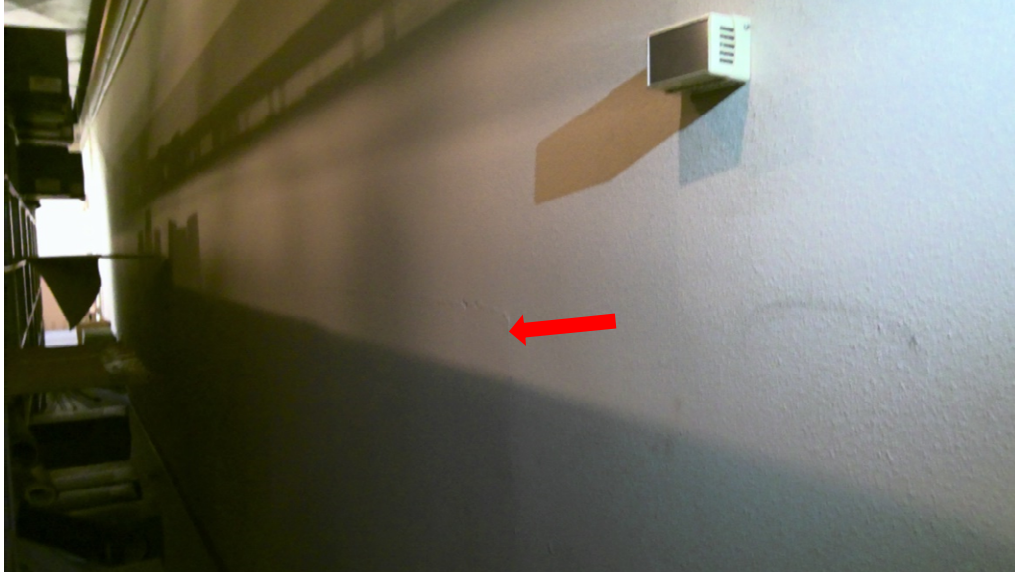
**Photo 29:** At the request of the Facilities Project Coordinator, cracking was observed within the gyp-board wall within the large storage room. This cracking was due to the gyp-board passing over the expansion joint without a metal expansion joint cover within the gyp-board wall.

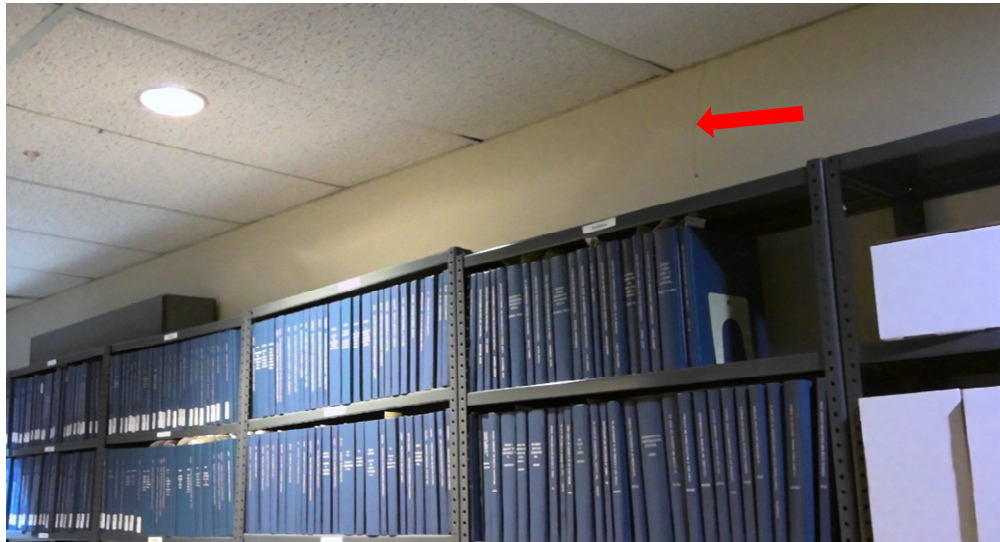
**Photo 30:** At the request of the Facilities Project Coordinator, cracking was observed within the gyp-board wall within the large storage room. This cracking was due to the gyp-board passing over the expansion joint without a metal expansion joint cover within the gyp-board wall.

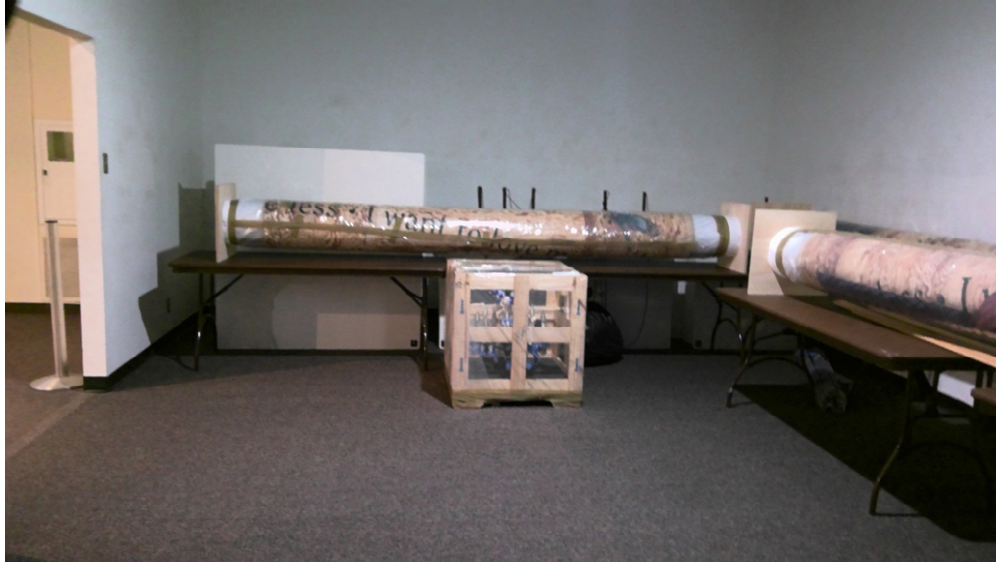
**Photo 31:** At the request of the Facilities Project Coordinator, tapestry is currently stored in front of elevator 3 on the exhibit second floor and the Facilities Project Coordinator was concerned with the weight of each tapestry roll bundled up in one area and the impact on the concrete structure below.

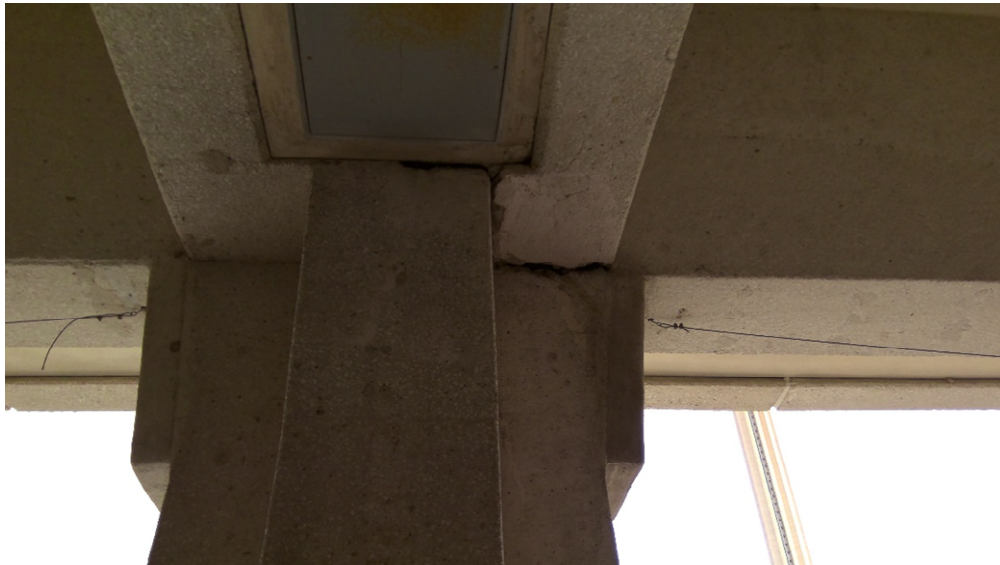
**Photo 32:** An existing structural repair was observed due to spalling of the concrete at an exterior concrete column at an expansion joint utilizing a corbel type condition at the top of the concrete column located on the West side of the building at the expansion joint furthest South on the exhibit Second-Floor level exterior corridor.

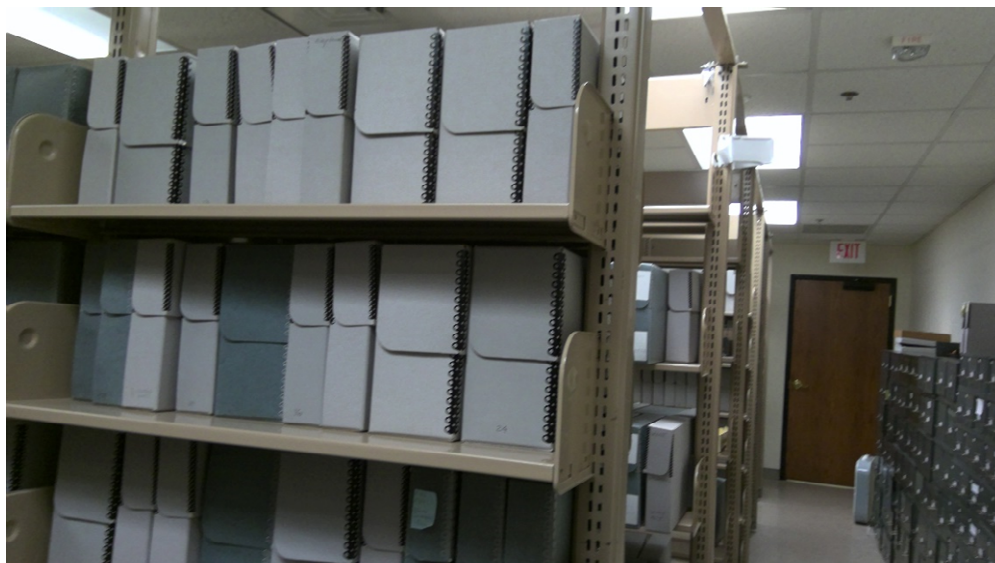
**Photo 33:** The First storage room (3.07.02) located on the South side of the building on the Third-Floor level contains cantilevered metal storage racks and metal catalogue rack stand with drawers.

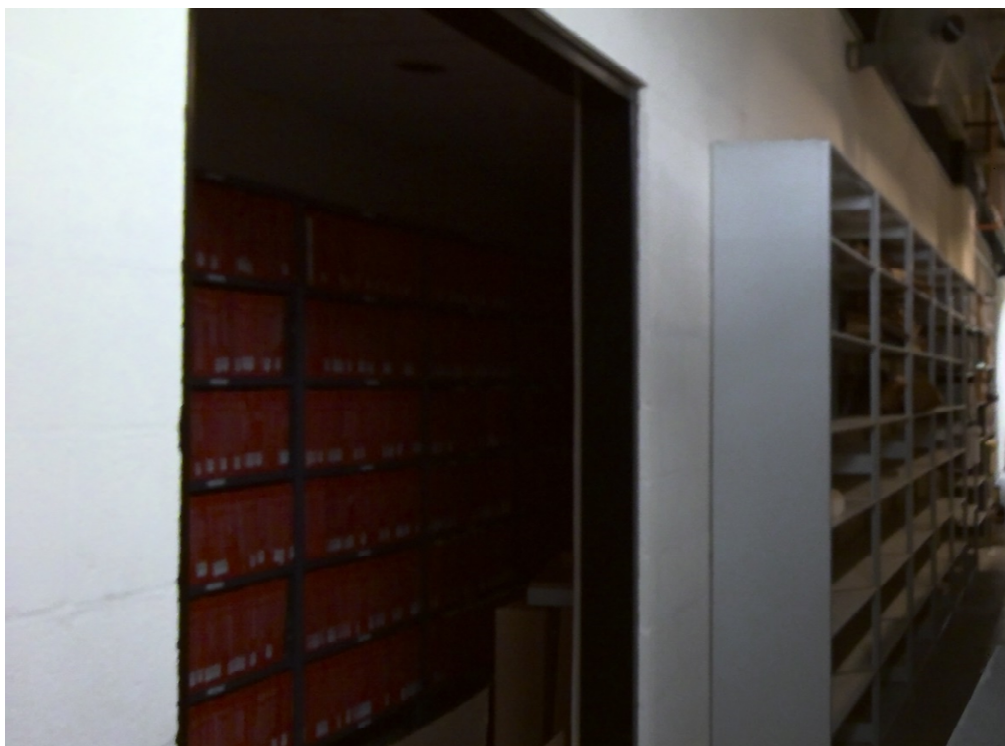
**Photo 34:** The Second storage room (3.08.07) located on the Southwest corner of the building on the Third-Floor level contains 4-post library metal storage racks within the large open area.

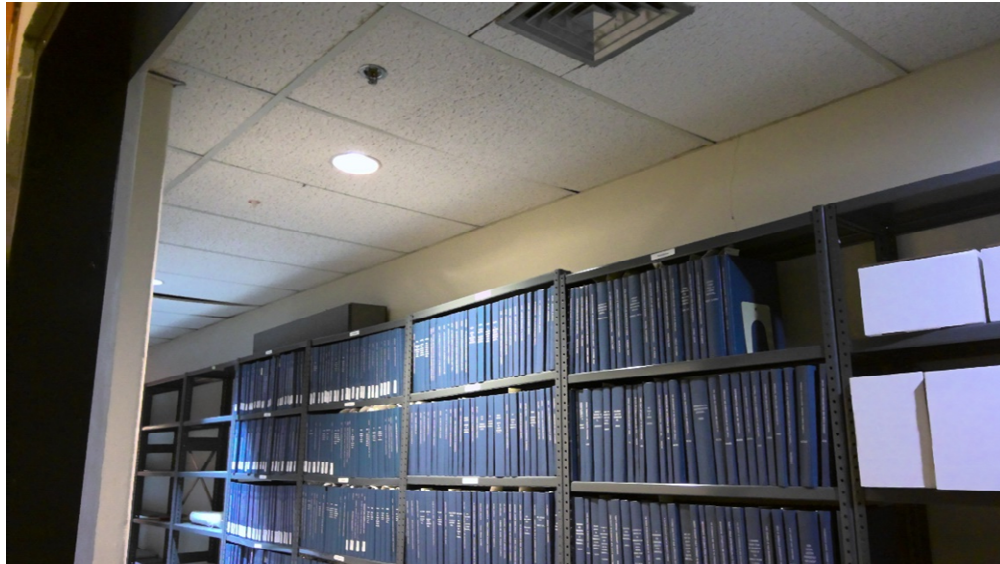
**Photo 35:** The Second storage room (3.08.07) had a smaller room attached to the large storage room located on the Southwest corner of the building on the Third-Floor level contains 4-post library metal storage racks within the long narrow area located over the cantilever floor of the existing structure.
