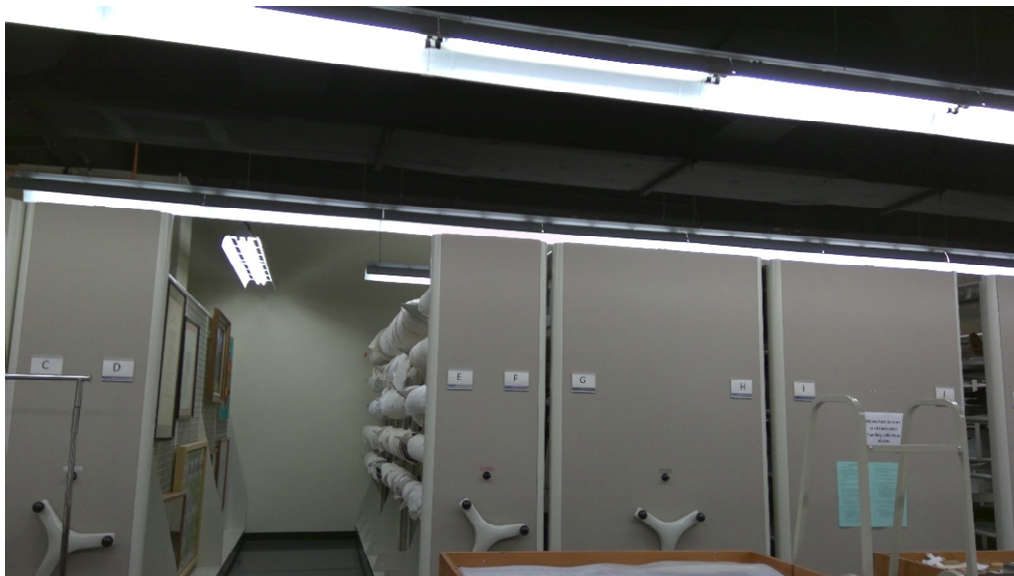
**Photo 36:** The Third storage room (3.04.19) located on the Southeast corner of the building on the Third-Floor level contains industrial compact mechanical assist mobile high density storage shelving.
