Institute of Texan Cultures

AAM Accreditation Facility Assessment Report

June 17, 2021

This project's goal is to assess the ability of the current Institute of Texan Cultures (ITC) facility to achieve AAM accreditation, and to identify the problems that might inhibit the ITC from achieving accreditation.

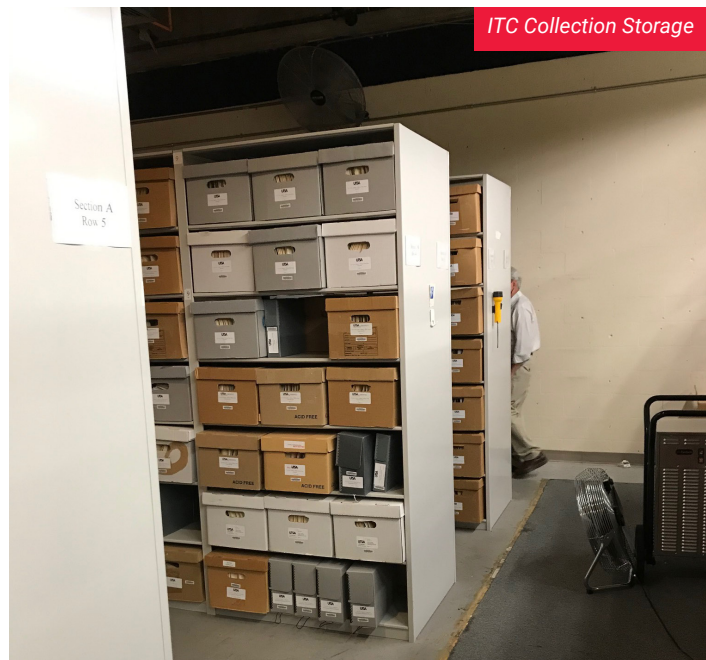
The total capacity of shelf space in the archives stacks is 5,204.5 linear feet (LF). Collections currently occupy 3,700 LF. Collections will increase a minimum of 375 LF this year. Taking into account this year and historical data from previous years, Collections staff anticipate growth of at least 1,000 LF over the next five years. Large collections, however, can come at any time without prior warning, for instance, when University departments suddenly decide to transfer their records. The existing collections storage rooms are at near-capacity.

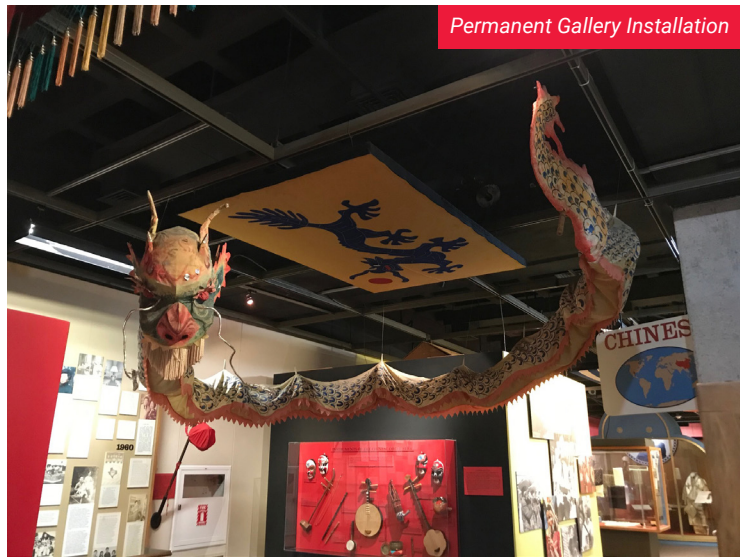
The existing building's very low ceilings, in some cases only 8'6" on floors 3 and 1, and only 10' to 12' on floor 2 restrict the use of material handling equipment, as forklifts and material-handling equipment require high ceiling clearance, prohibit the installation of large or tall exhibition objects, etc.

The low ceiling heights also restrict the use of extensive, more-space-efficient compact storage. All of the ITC's current collection storage equipment, including recently-installed compact storage units represent low-height units that use space very inefficiently.

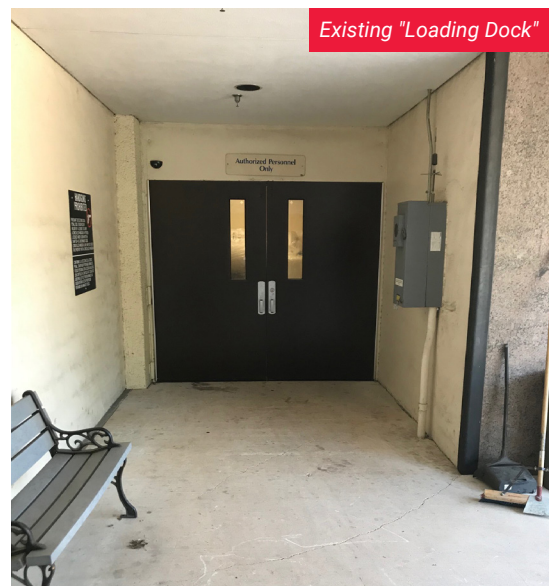
This further constricts the available object movement space at the doorway. This constriction limits the staff’s ability to bring in large exhibit-related boxes, crates, etc. Inside the doors there is a very low ceiling of 7’ 6”. The space is so small and low that the ITC staff are unable to bring in many exhibit object shipping crates.

The installation staff are also unable to use forklifts or larger material handling equipment which represent the basic professional standard for all museums.

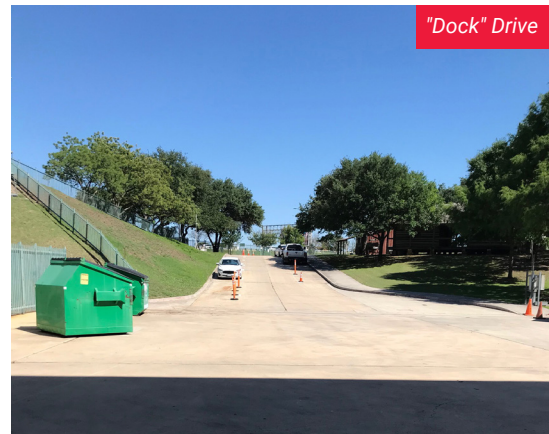
Added to the problem of no loading dock, there is no truck turnaround / back-in space at the loading / receiving area. All art and loan exhibition delivery trucks tend to be long-distance semi-tractor trailers. These extend 65' to 70' from front bumper to back bumper. Trucks can weigh 70,000 lbs., fully-loaded, with exterior widths sometimes in excess of 8'2".

Accreditation standards necessitate a professional-level loading dock with all associated material/delivery handling equipment, a hydraulic dock lift or scissor lift, etc. The building has no capacity to support these requirements. The accreditation process casts a close review of all loading and receiving areas. The ITC could not be accredited because of these problems.

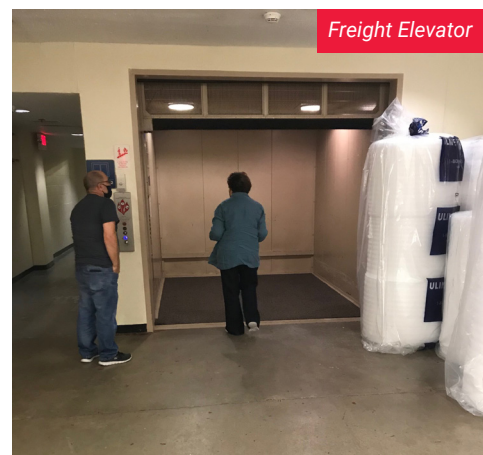
There are currently two working personnel elevators and one working freight elevator. Only two personnel elevators are functional, as the third has been cannibalized for parts to service the remaining working elevators because parts for these elevators are no longer made. ITC and UTSA Libraries have initiated a project to upgrade and update the two remaining passenger elevators.

The ITC will require all new elevators very soon. The current condition and availability of the freight elevator (not the personnel elevators) will affect the museum's ability to be accredited. We note that the freight elevator's dimensions are smaller than what is typically found in similar museum facilities, and may impede the movement of large-scale objects from the first floor to the galleries or collection storage areas.

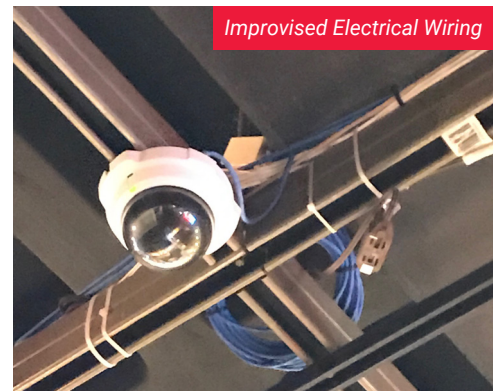
Electrical issues.

The ITC's electrical system is now approximately 53 years old. In the intervening five decades, as the prep and installation staff worked on various installations, they installed numerous pieces of impromptu, drop down, and/or exposed surface wiring.

Throughout the building, the electrical system does not meet the ITC's (nor the museum profession's) installation needs or requirements, especially on the gallery floor, and in and above the two-story dome on floor levels two and three. These issues impact the museum's ability to be accredited.

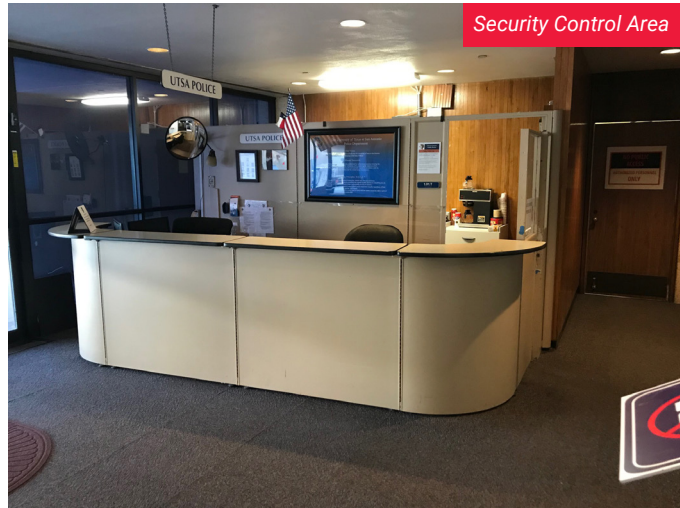
The current security control room does not meet professional standards:

- No separate, hardened and secure security room
- No dedicated security panel
- No secure security system network closet
- No multiple location security camera monitoring, no unified security video console/monitor system.
- The security area is now an open-plan "desk" which is also used as a staff break/lunch room. Museum security control rooms should always be separate, fully-secure, locked rooms.

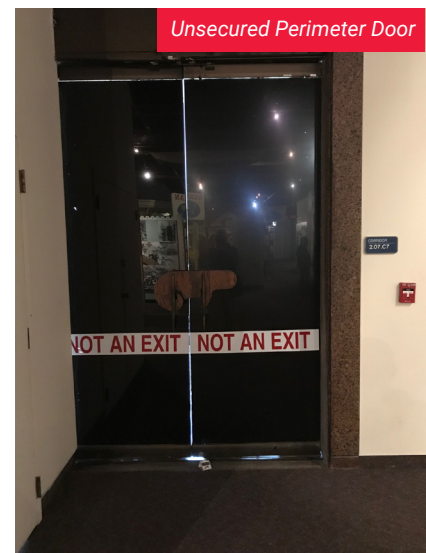
Primarily due to the age of the original security system, there are significant gaps in security coverage:

- Not all perimeter doors are alarmed
- Very few (fewer than 5) exterior cameras exist and all are analog.
- There are very few (fewer than 10) interior cameras
- There are very few intrusion points (e.g. air ducts) which have access monitoring or have intrusion detection equipment
- All doors are locked using physical keys, not electronic keycards.

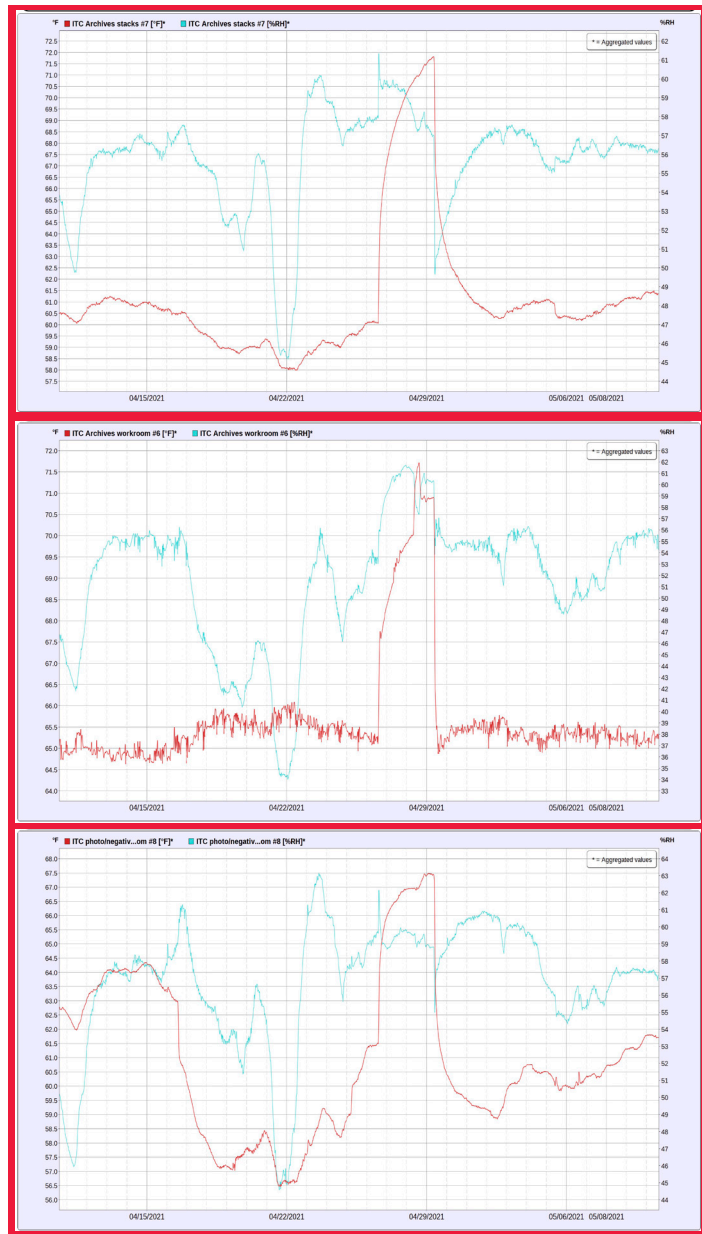
The ITC also holds a large number of audiovisual material estimated to consist of more than 3,000 items. Like photographs, audiovisual materials (reel to reel, Umatic, Betamax, cassette tapes, VHS, etc) require specific temperature and humidity control. The temperature requirements for AV are even colder than photographs: 46 degrees/35% humidity.

An electronic datalogger system is used to monitor temperature and humidity. The current number of monitoring “points” or locations is insufficient to meet professional standards.
